# **GARDEN GATE ELEMENTARY SCHOOL**

**2020 | FACILITIES MASTER PLAN**

# FACILITY CONDITION ASSESSMENT

**GARDEN GATE ELEMENTARY SCHOOL**  
10500 ANN ARBOR AVENUE  
CUPERTINO, CALIFORNIA 95014

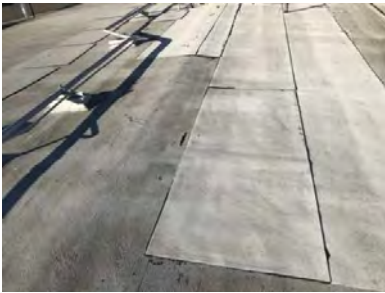
### Roof in Poor condition.

Built-Up  
Administration Building 900 Roof

Uniformat Code: B3011  
Recommendation: **Replace in 2021**

Replacement based on roof report. - AssetCALC ID: 1458234

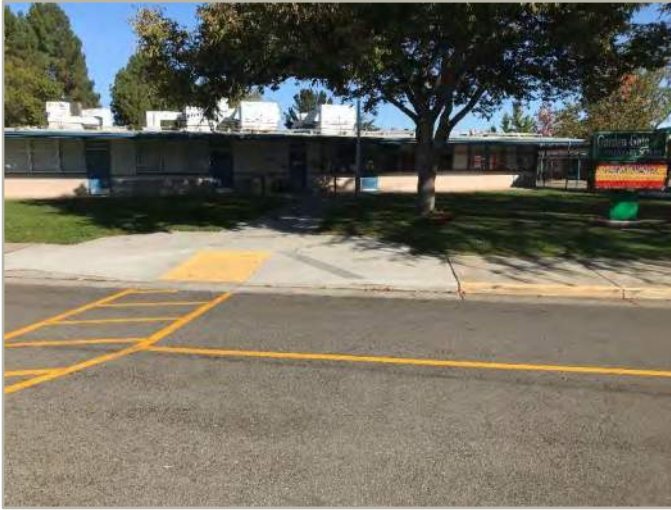
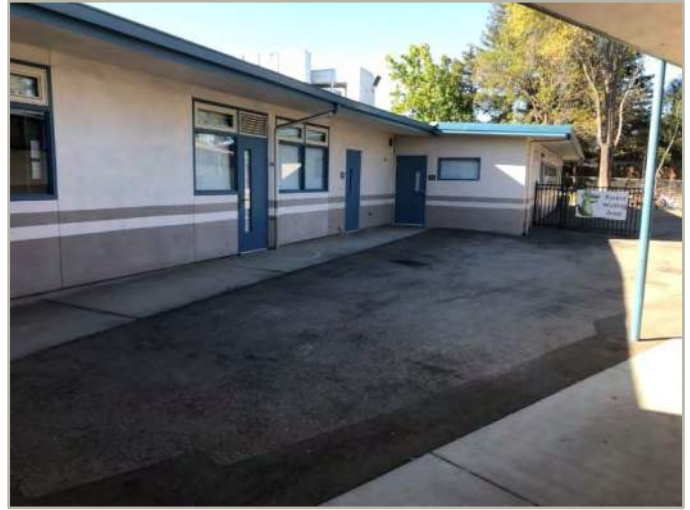
## 2. Administration Building 900

| <b>Key Issues and Findings</b> | Roof replacement is recommended. | |

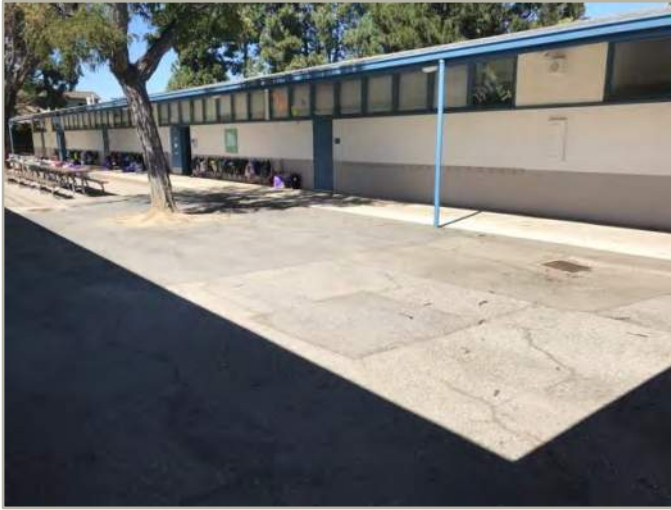
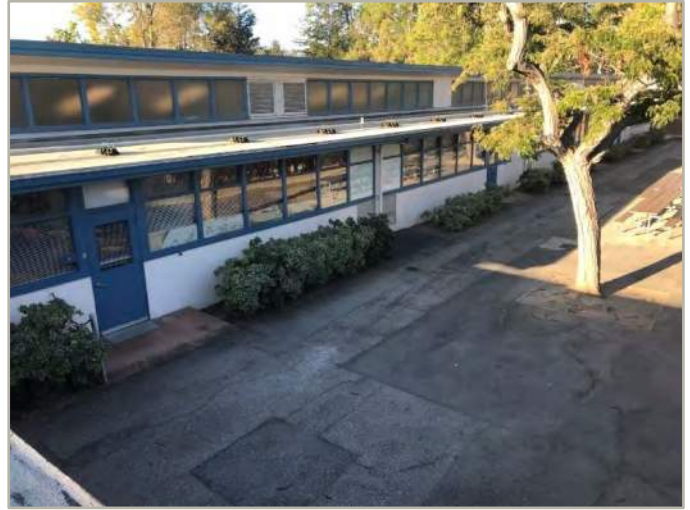
### 3. Classroom Buildings 1-12/19-21

| <b>Key Issues and Findings</b> | Comprehensive replacement of building components as they reach the end of their useful service life. | |

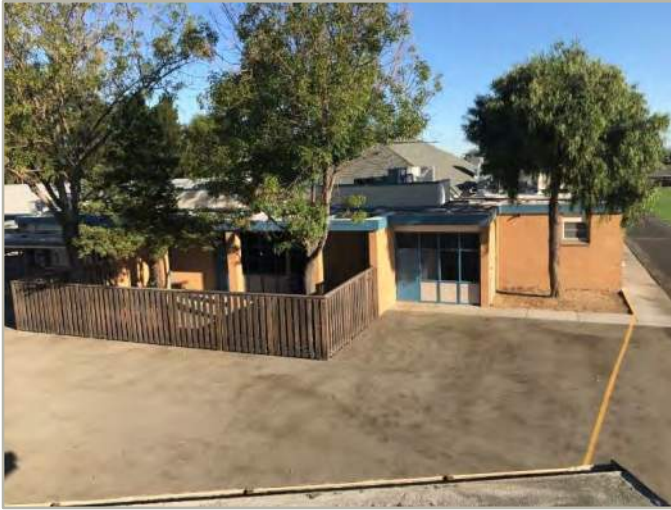
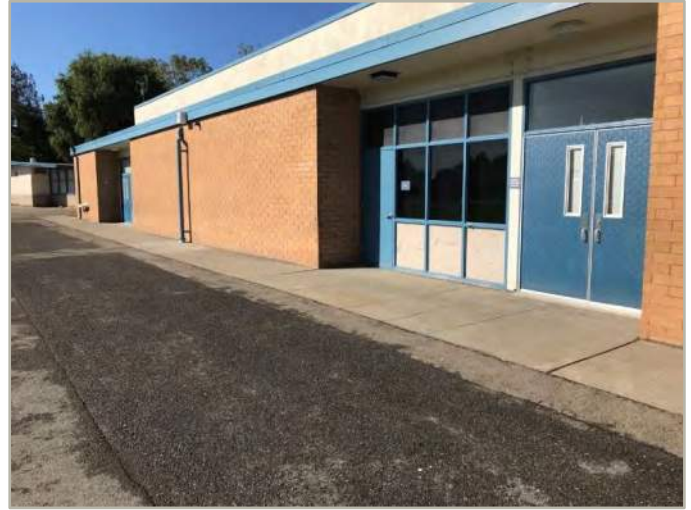
## 4. Guided Learning Center GLC 920

| <b>Key Issues and Findings</b> | Comprehensive replacement of building components as they reach the end of their useful service life. | |

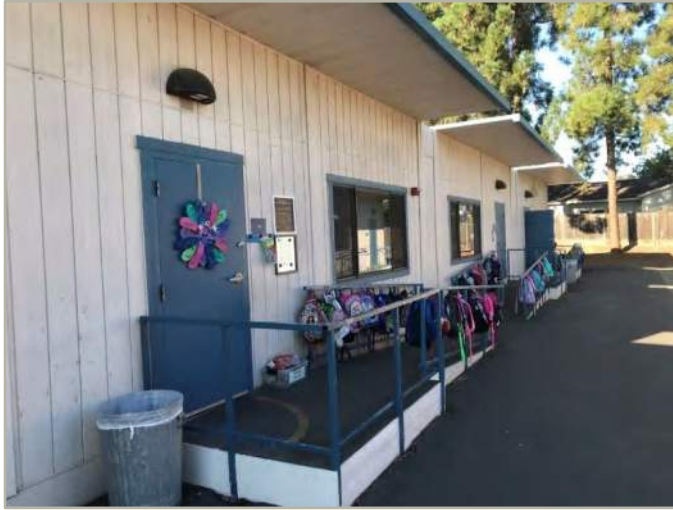
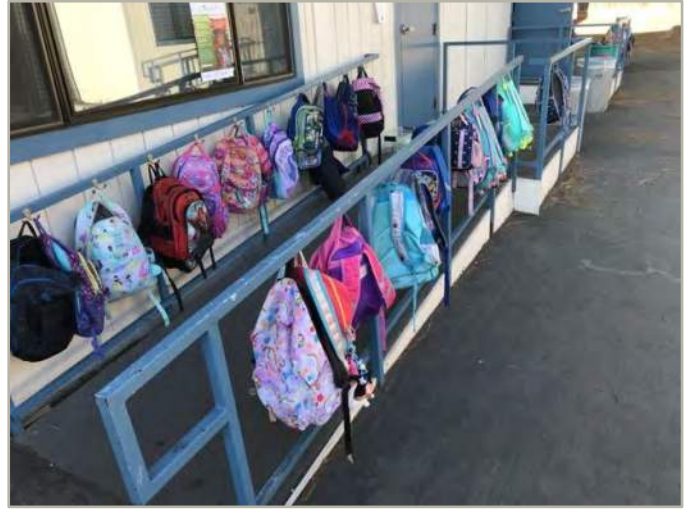
## 5. Modular Classrooms 17/18/22-35

| <b>Key Issues and Findings</b> | Comprehensive replacement of building components as they reach the end of their useful service life. | |

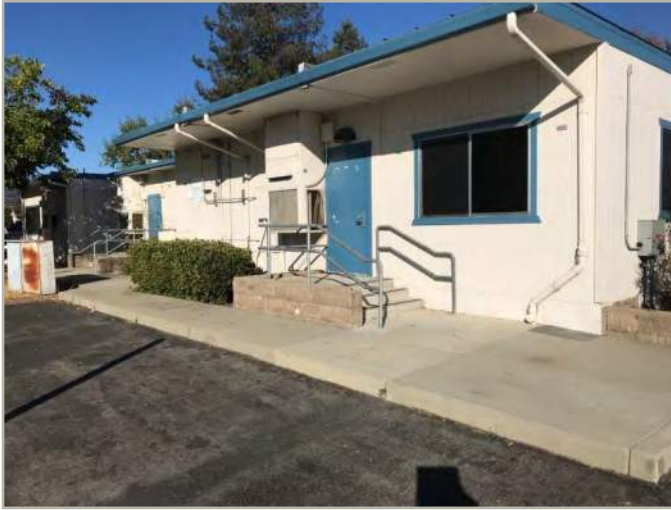
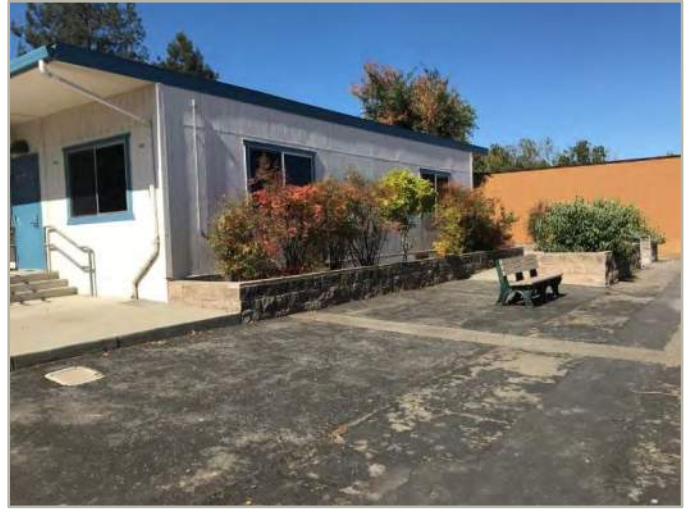
## 6. Child Development Center CDC 31/32

| <b>Key Issues and Findings</b> | Comprehensive replacement of building components as they reach the end of their useful service life. | |

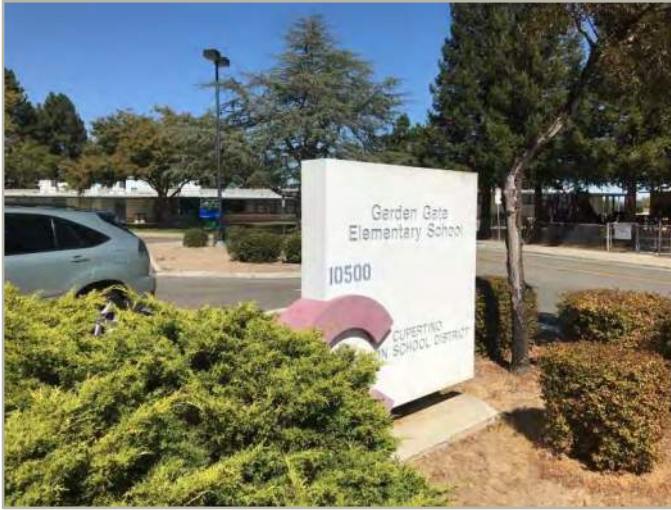
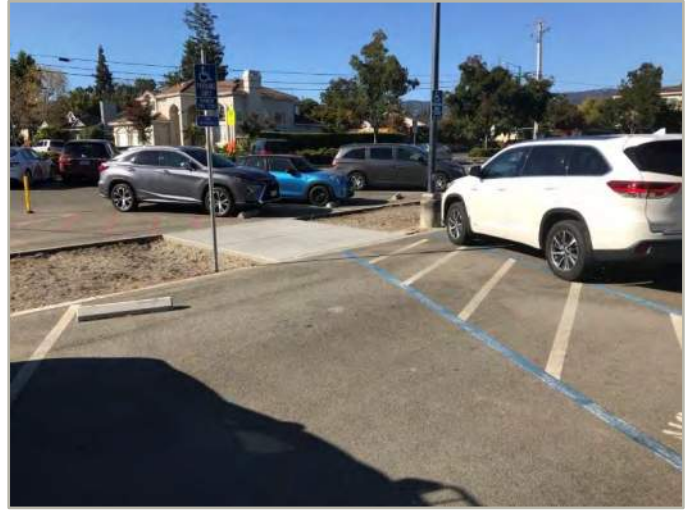
## 7. Site Summary

| <b>Key Issues and Findings</b> | No significant deficiencies observed. Comprehensive replacement of site components as they reach the end of their useful service life | |
