FACILITY NEEDS ASSESSMENTS  
**MILLER MIDDLE SCHOOL**

**2020** | FACILITIES MASTER PLAN

# FACILITY CONDITION ASSESSMENT

MILLER MIDDLE SCHOOL  
6151 RAINBOW DRIVE  
SAN JOSE, CALIFORNIA 95129

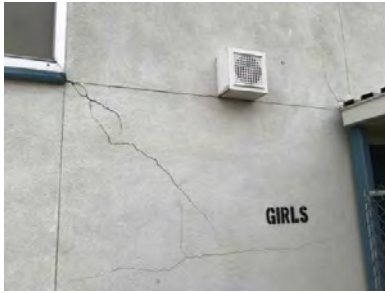
### Exterior Wall in Poor condition.

Stucco, 1-2 Stories  
PE Building Exterior

Extensive cracking observed. - AssetCALC ID: 1489332

Uniformat Code: B2011  
Recommendation: **Replace in 2021**

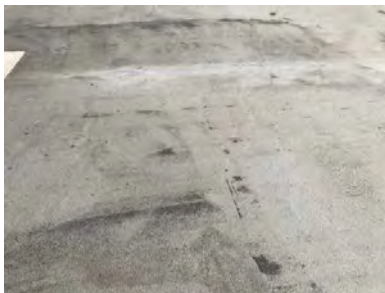
### Roof in Poor condition.

Modified Bituminous  
Classroom Buildings CR 1-6, 13-33, 37-38

Heavily worn, vegetative growth observed - AssetCALC ID: 1489160

Uniformat Code: B3011  
Recommendation: **Replace in 2020**

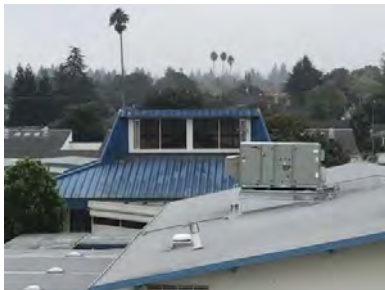
### Roof in Poor condition.

Modified Bituminous  
Library 920 (Low Slope)

Signs of leaks, damaged membrane - AssetCALC ID: 1528293

Uniformat Code: B3011  
Recommendation: **Replace in 2021**

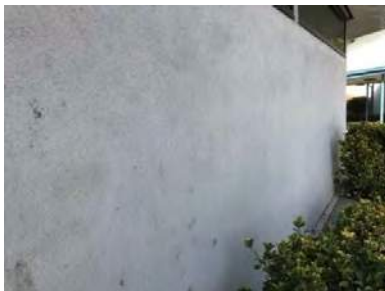
### Exterior Wall in Poor condition.

Stucco, 1-2 Stories  
Library Building Exterior

Cracking observed across stucco - AssetCALC ID: 1489199

Uniformat Code: B2011  
Recommendation: **Replace in 2021**

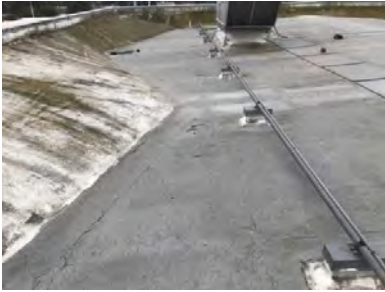
**Roof in Poor condition.**

Modified Bituminous  
Gym (Low Slope)

Signs of leaks, vegetation growth, damaged membrane - AssetCALC ID: 1489182

Uniformat Code: B3011  
Recommendation: **Replace in 2020**

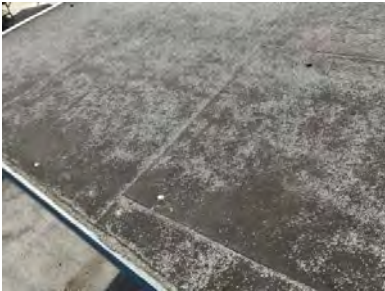
**Roof in Poor condition.**

Modified Bituminous  
M/U CR 31

Heavily worn, vegetative growth observed - AssetCALC ID: 1489341

Uniformat Code: B3011  
Recommendation: **Replace in 2021**

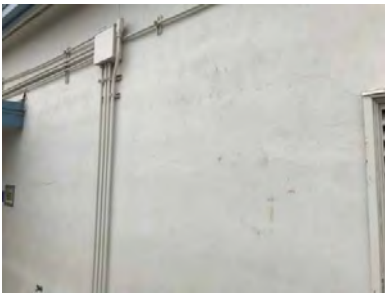
**Exterior Wall in Poor condition.**

Stucco, 1-2 Stories  
M/U Building Exterior

Cracking observed across stucco - AssetCALC ID: 1489130

Uniformat Code: B2011  
Recommendation: **Replace in 2021**

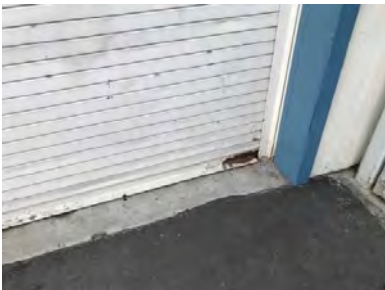
**Overhead/Dock Door in Poor condition.**

144 SF  
PE Building Exterior

Doors are rusted and dented. - AssetCALC ID: 1489174

Uniformat Code: B2034  
Recommendation: **Replace in 2021**

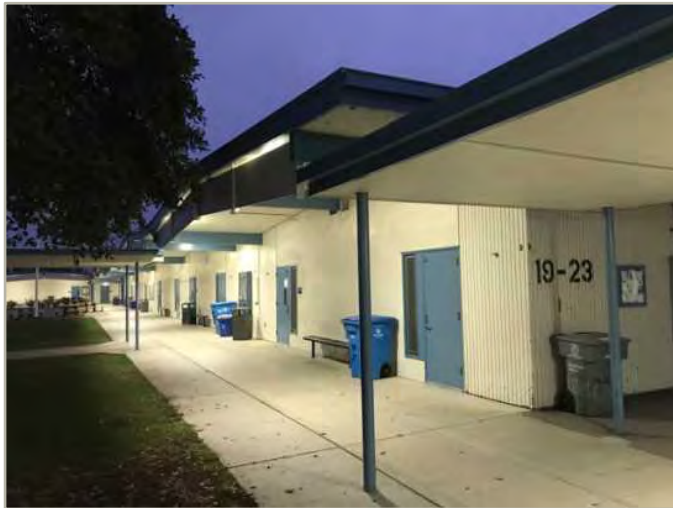
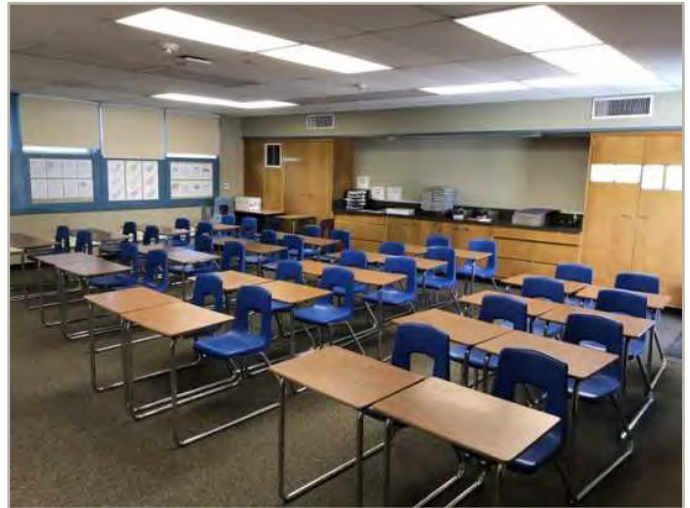
## 2. Classrooms

| <b>Key Issues and Findings</b> | Modified bituminous roof in need of replacement on most of the classrooms, no fire extinguishers, no emergency lighting |

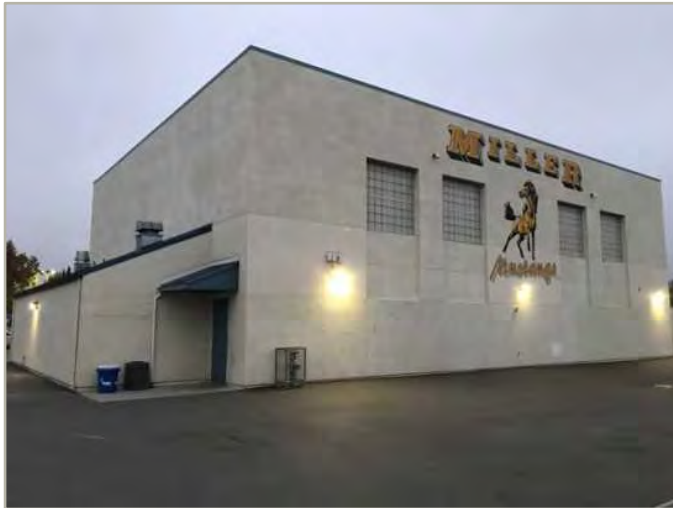
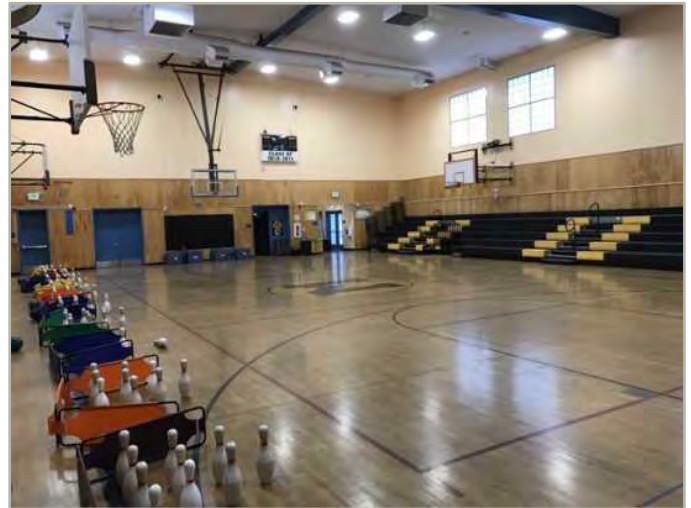
### 3. Gym

Modified bituminous roof in need of replacement, no fire extinguishers, no emergency lighting

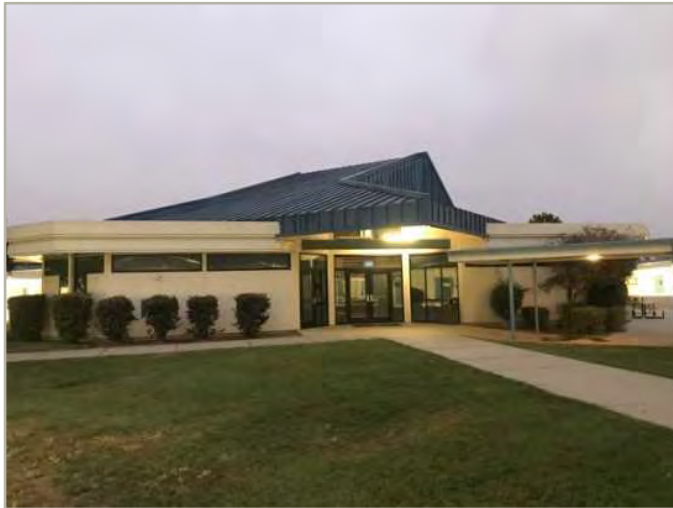
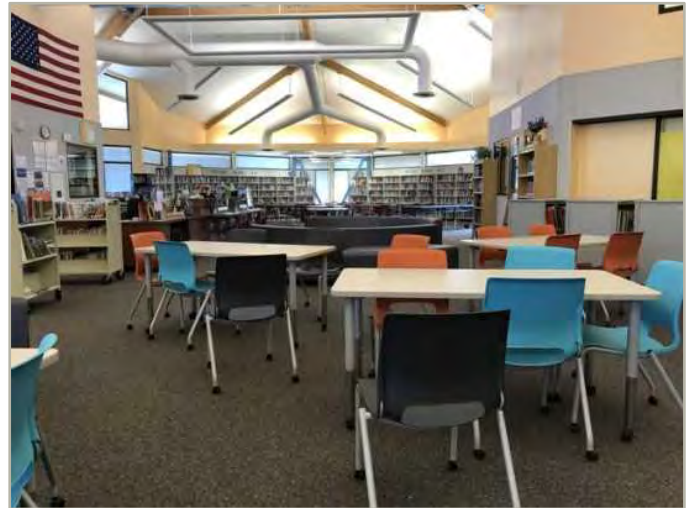
## 4. Library

Stucco cracking and chipping, modified bituminous roof in need of replacement, no fire extinguishers, no emergency lighting

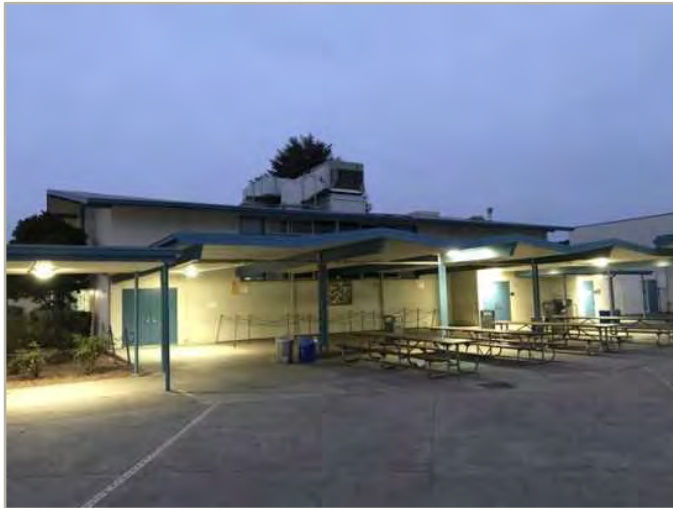
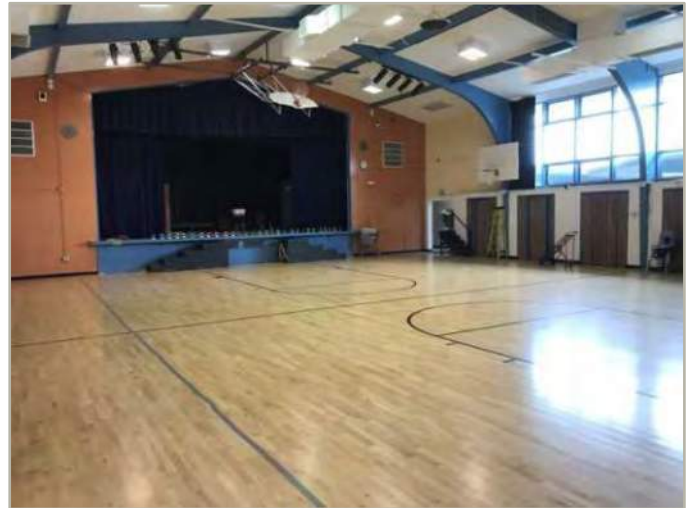
## 5. Multipurpose

| <b>Key Issues and Findings</b> | Stucco cracking and chipping, a portion of the modified bituminous roof in need of replacement, no fire extinguishers, no emergency lighting |

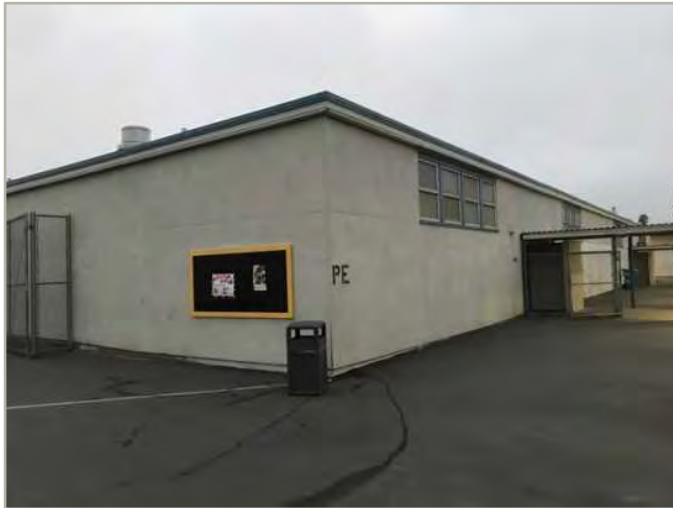
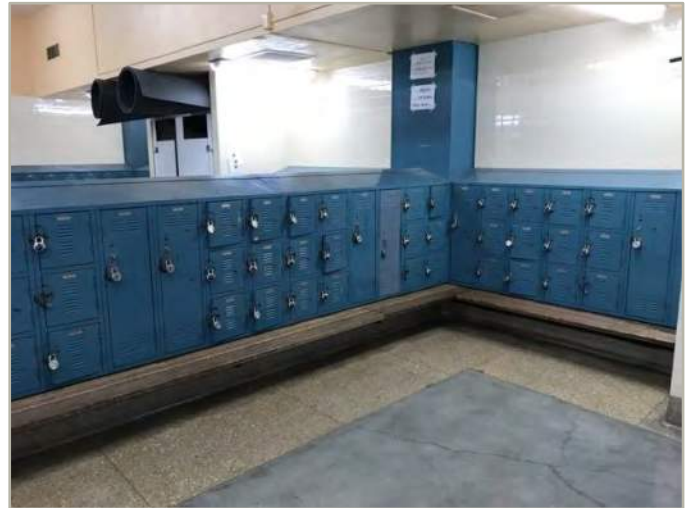
## 6. PE Building

| <b>Key Issues and Findings</b> | Modified bituminous roof in need of replacement, only one fire extinguisher, no emergency lighting, no exit signs | |

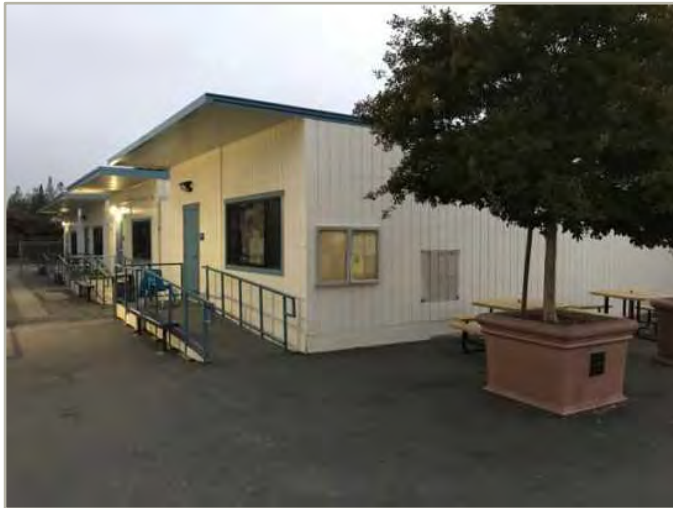
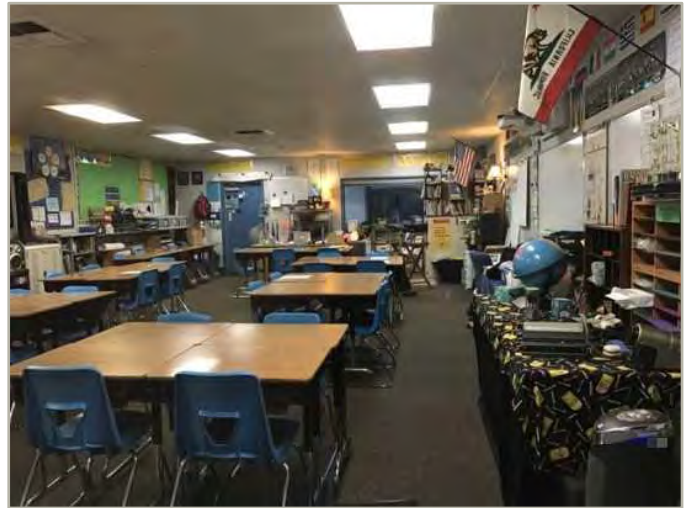
## 7. Portables

**Key Issues and Findings** No fire extinguishers, no emergency lighting, no exit signs

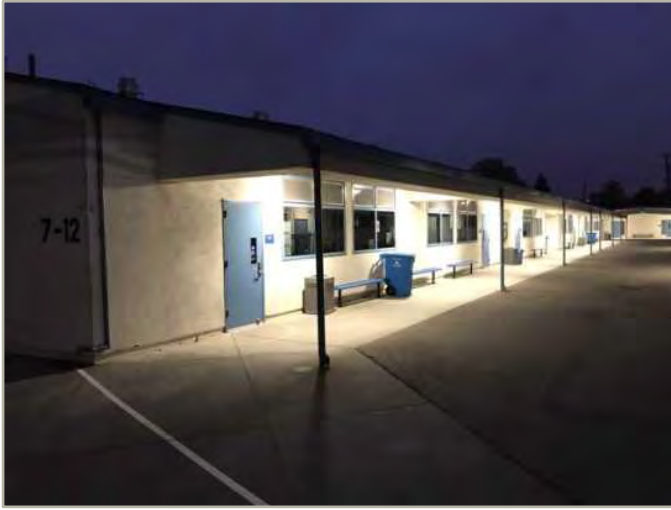
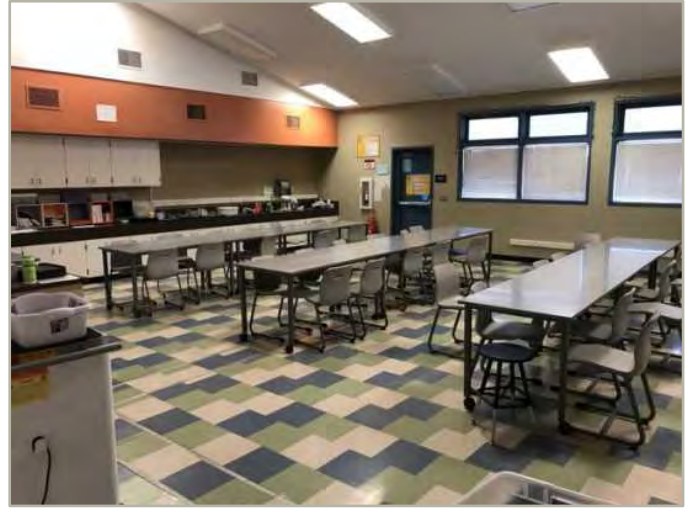
## 8. Science Wing

| <b>Key Issues and Findings</b> | No fire extinguishers, no emergency lighting, no exit signs | |
