## Bancroft Elementary School

#### **Property Executive Summary**

### Facility Condition Index

### Summary of Findings

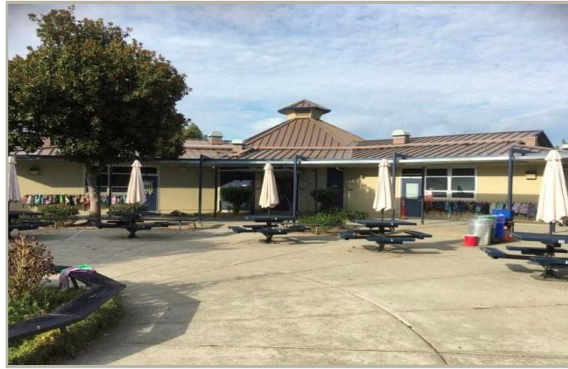
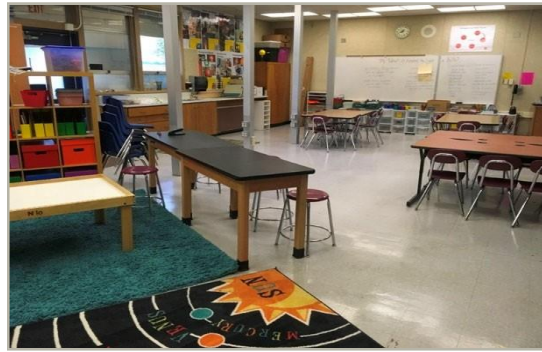
### Building Type 1 Information

| Building Type 1 Information | | |
|---|---|---|
| <b>Key Issues &amp; Findings</b> | Buildings lack fire suppression, numerous complaints of low light levels both inside and outside, sink drains in renovated restrooms are not wrapped per ADA, some floor tile is 9"x9" which may contain asbestos | |

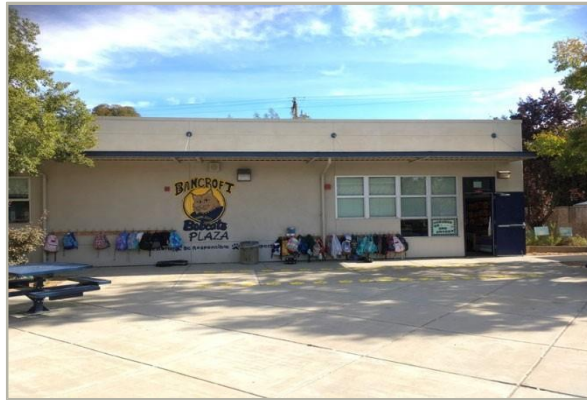
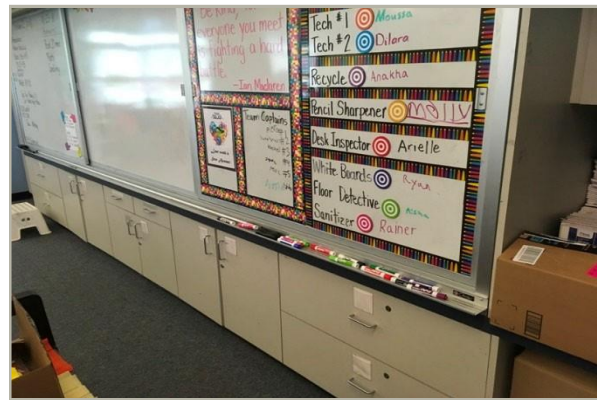
### Building Type 2 Information

| Building Type 2 Information | | |
|---|---|---|
| <b>Key Issues &amp; Findings</b> | Building lacks fire suppression | |

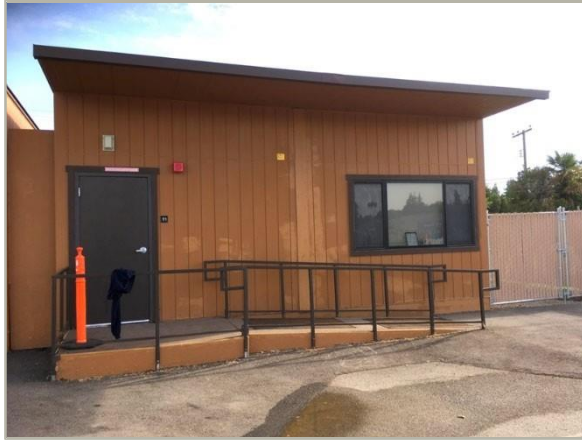
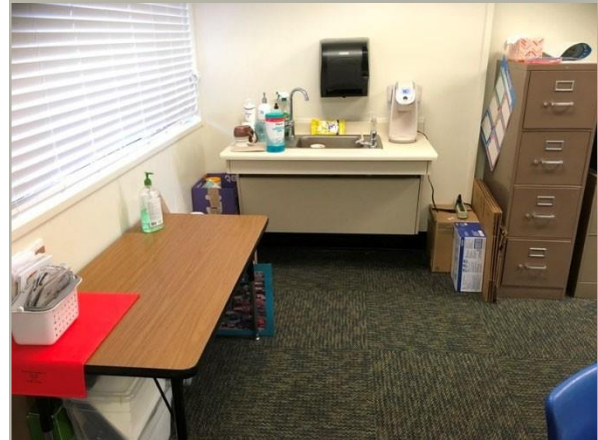
### Building Type 3 Information

| Building Type 3 Information | | |
|---|---|---|
| <b>Key Issues &amp; Findings</b> | No fire suppression | |

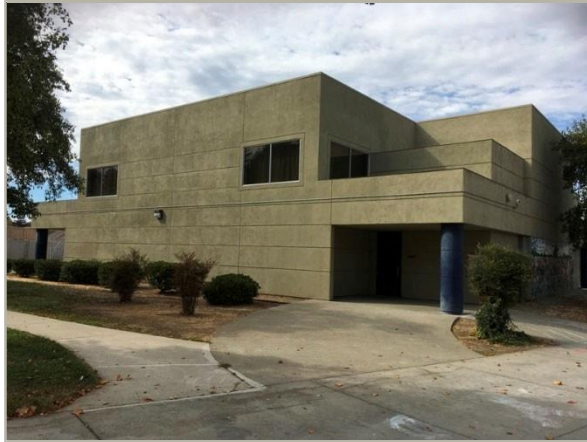
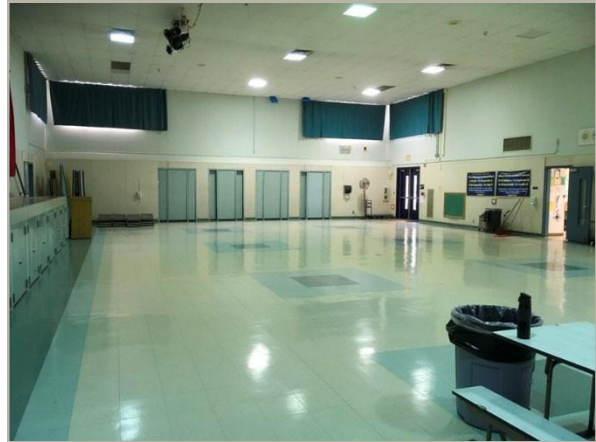
### Building Type 4 Information

| Building Type 4 Information | | |
|---|---|---|
| <b>Key Issues &amp; Findings</b> | Building lacks fire suppression | |

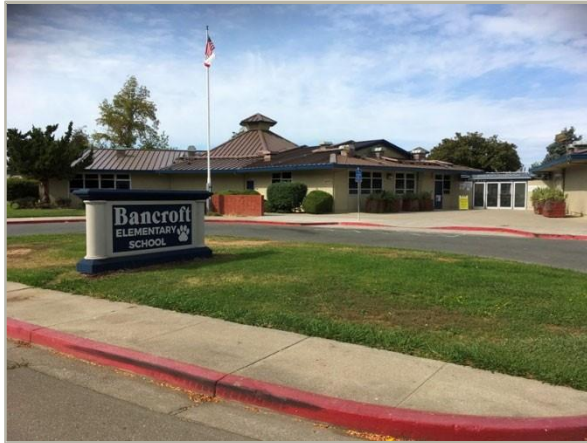
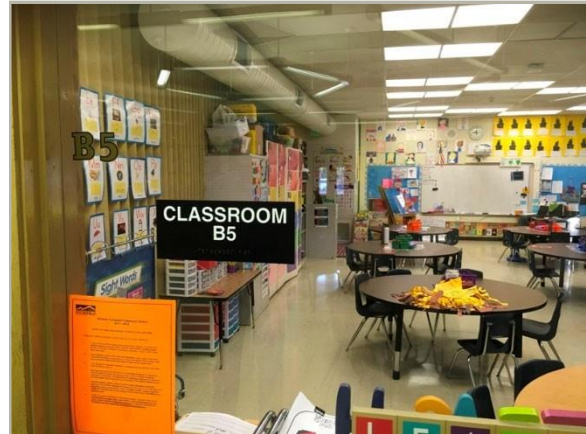
### Site Summary Information

| Site Information | | |
|---|---|---|
| <b>Key Issues &amp; Findings</b> | Goose problem creates a mess for kids and staff, weekend trespassing issues exacerbated by lack of site lighting, Classroom A3 has water infiltration during rain events | |
