## Valle Verde Elementary School

### OVERVIEW

#### **Property Executive Summary**

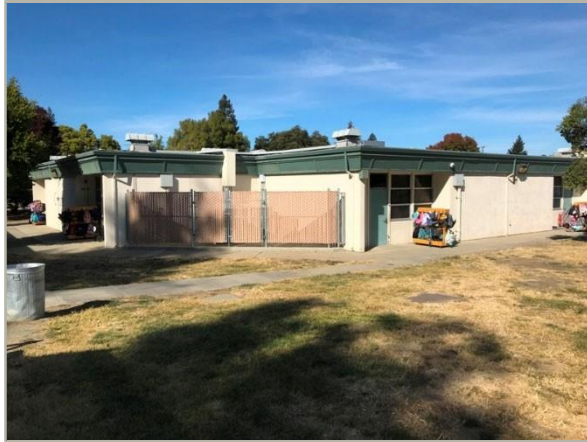
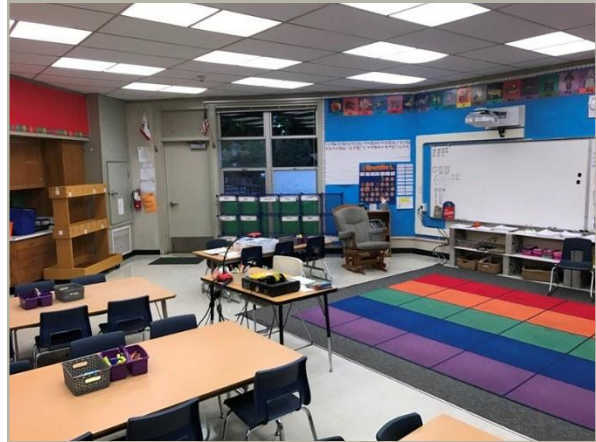
### Building Type 1 Information

| Building Type 1 Information | | |
|---|---|---|
| <b>Key Issues &amp; Findings</b> | Building lacks complete fire suppression systems | |

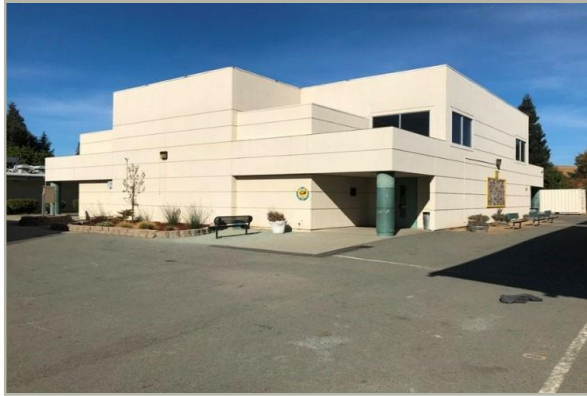
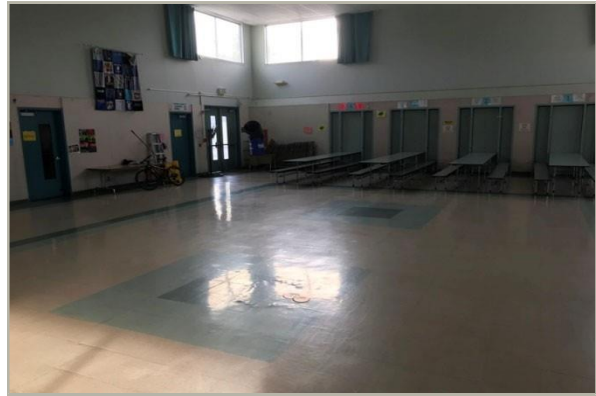
### Building Type 2 Information

| Building Type 2 Information | | |
|---|---|---|
| <b>Key Issues &amp;<br/>Findings</b> | Expired fire extinguisher inspection tags noted, backstage area of M-U Building | |
