## Shore Acres Elementary School

## Shore Acres Elementary School **SCHOOL SITE ENGAGEMENT**

## **ASSESSMENT OF SITE**

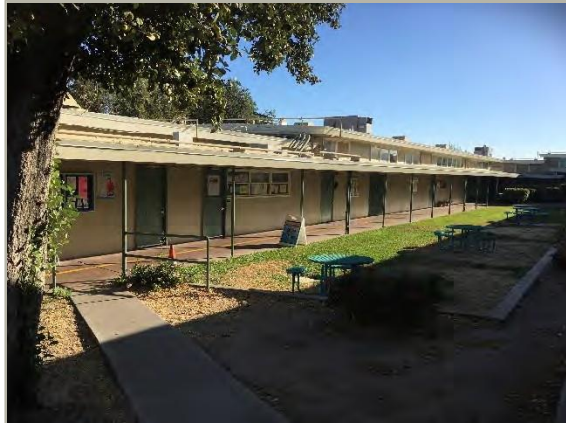
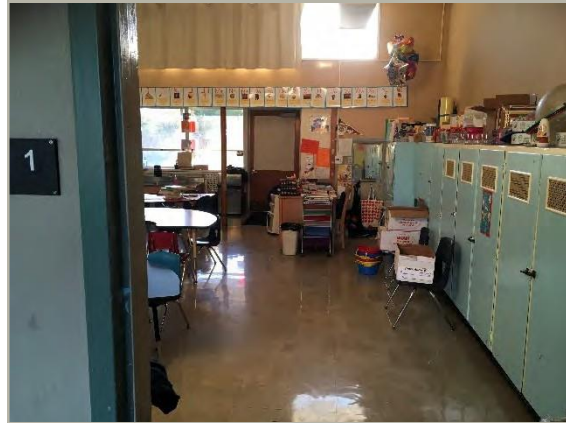
| Building Type 1 Information | | |
|---|---|---|
| <b>Key Issues &amp; Findings</b> | Broken roof drain creates water pooling on the ground near Classroom 8 | |

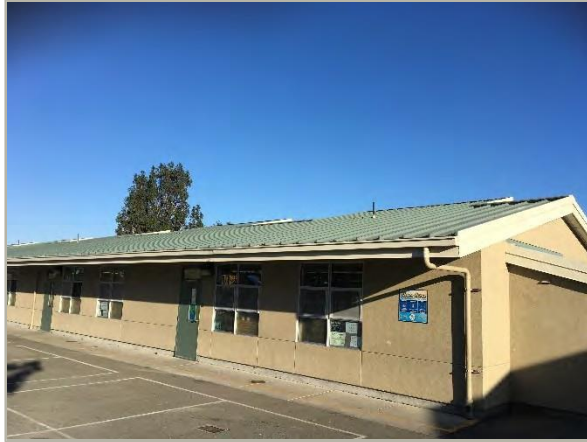
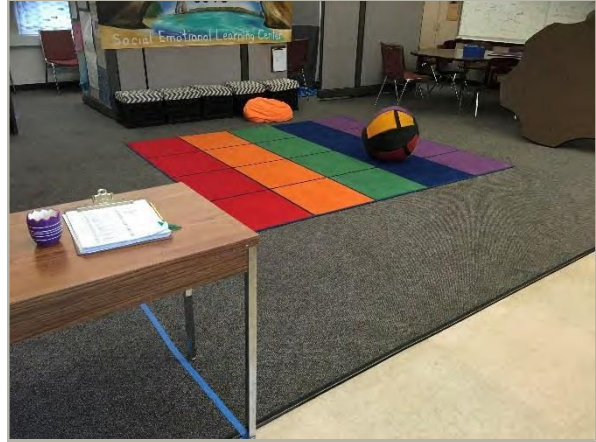
| Building Type 2 Information | | |
|---|---|---|
| <b>Key Issues &amp; Findings</b> | Buildings lack fire suppression | |

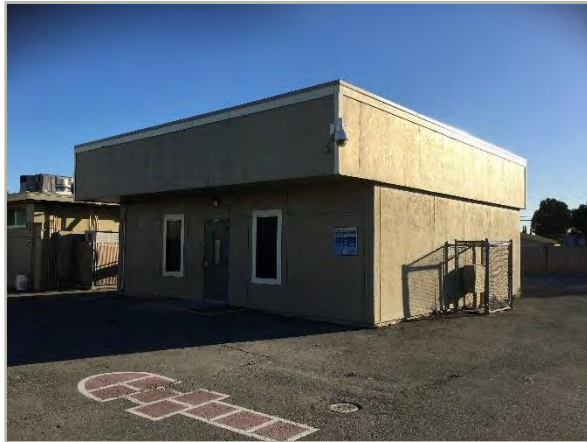
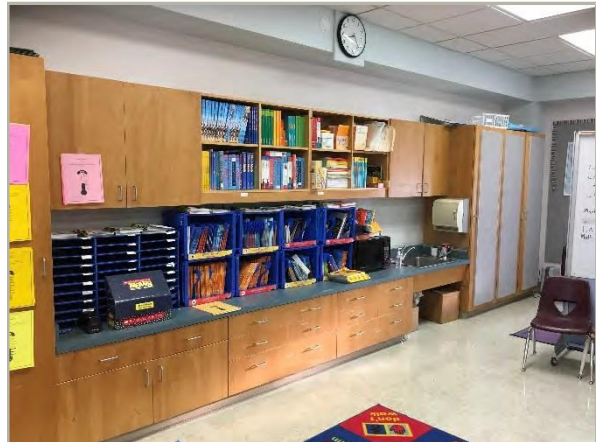
| Building Type 2 Information | | |
|---|---|---|
| <b>Key Issues &amp; Findings</b> | Building lacks fire suppression | |

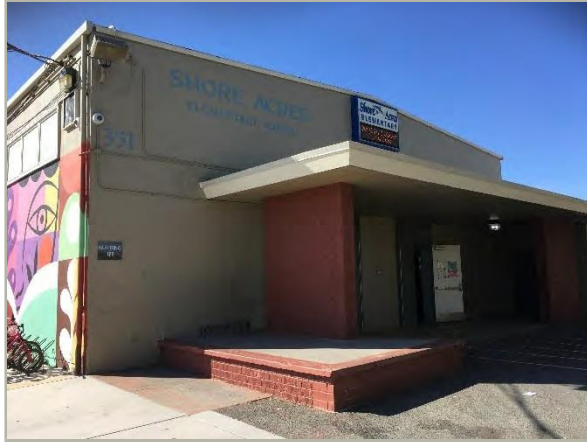
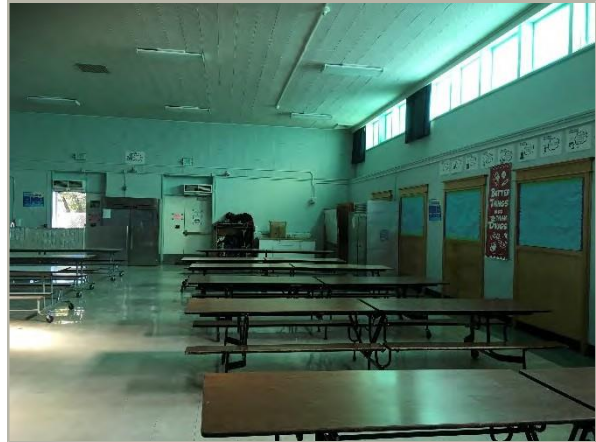
| Building Type 4 Information | | |
|---|---|---|
| <b>Key Issues &amp; Findings</b> | Building lacks fire suppression, kitchen hood lacks fire suppression | |

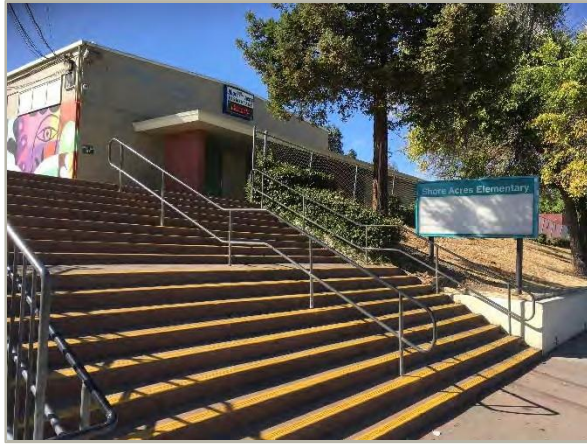
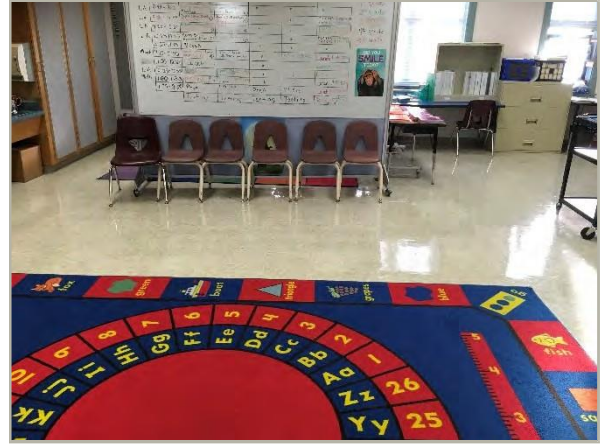
| Site Information | | |
|---|---|---|
| <b>Key Issues &amp; Findings</b> | Broken gutter drain pipe near Classroom 8, some asphalt buckling and cracking in kindergarten play area | |
