## Walnut Acres Elementary School

### OVERVIEW

#### **Property Executive Summary**

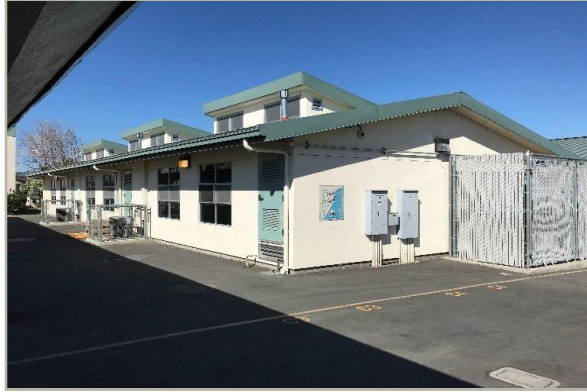
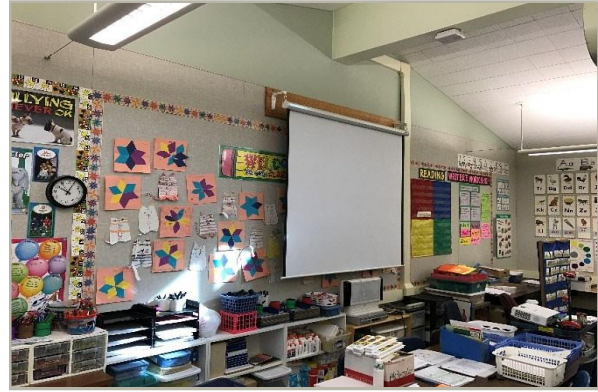
| Building Type 2 Information | | |
|---|---|---|
| <b>Key Issues &amp;<br/>Findings</b> | Buildings generally lack fire suppression | |

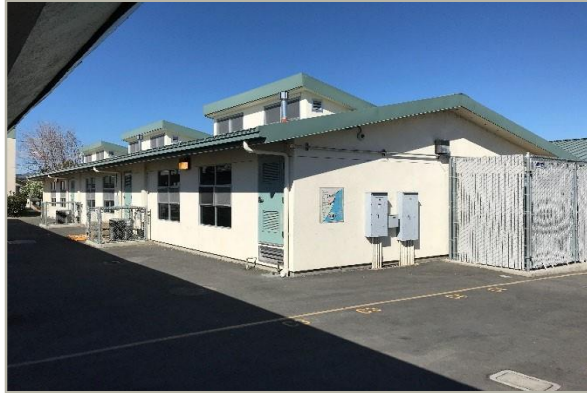
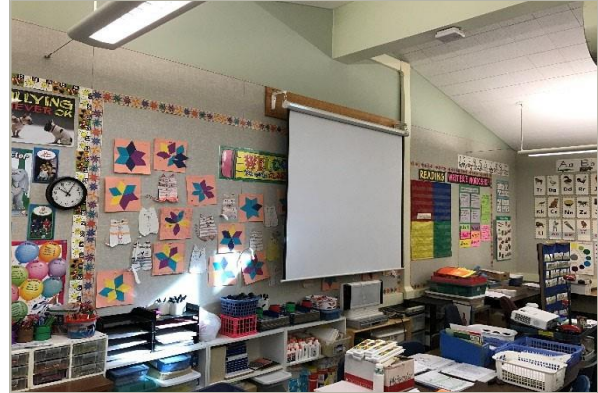
| Building Type 2 Information | | |
|---|---|---|
| <b>Key Issues &amp;<br/>Findings</b> | Buildings generally lack fire suppression | |

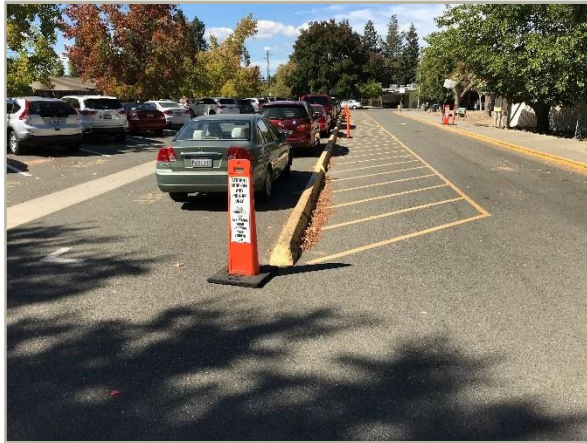
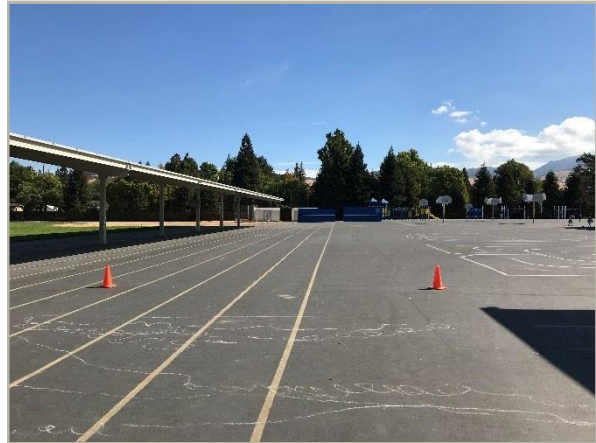
| Site Information | | |
|---|---|---|
| <b>Draining Systems and Erosion Control</b> | Surface flow and municipal system<br>Ponding occurs in the landscaped areas adjacent to the play court<br>The concrete drainage swales have isolated areas of cracking and spalling<br>The concrete sumps and sump pumps have a history of back-ups and clogs.<br>The stormwater management retention pond has silt deposits, an accumulation of trash and debris, and soil erosion in the pond | Fair |
| <b>Key Issues &amp; Findings</b> | Ponding in the grass yard | |
