## Woodside Elementary School

### OVERVIEW

#### **Property Executive Summary**

### Building Type 1 Information

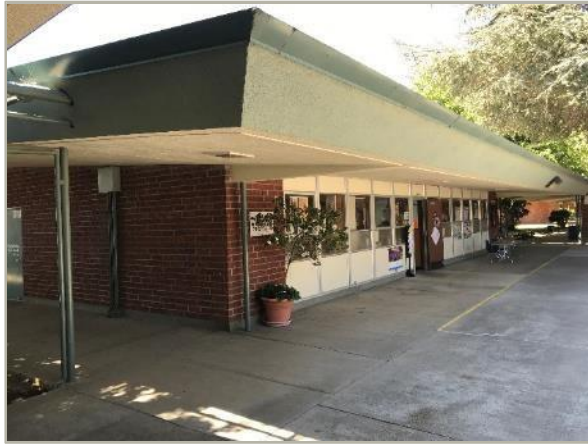
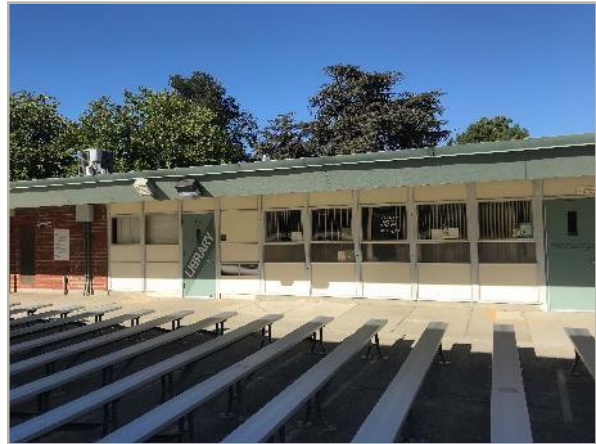
| Building Type 1 Information | | |
|---|---|---|
| <b>Key Issues &amp; Findings</b> | Buildings lack fire sprinklers, illuminated exit signs, emergency lighting | |

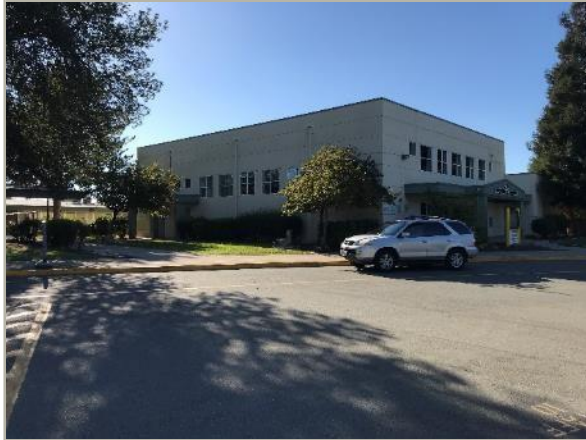
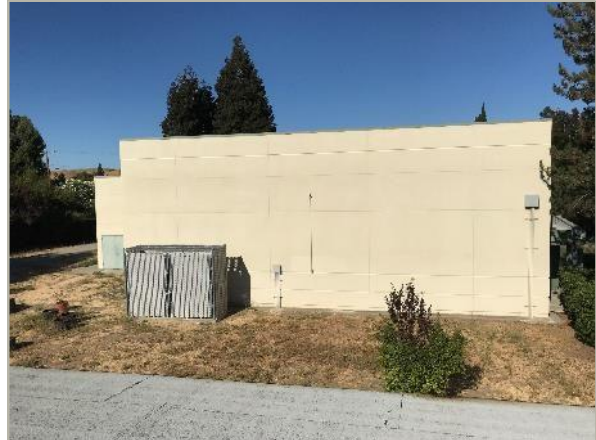
### Building Type 3 Information

| Building Type 3 Information | | |
|---|---|---|
| <b>Key Issues &amp; Findings</b> | Roof was inaccessible during site visit | |

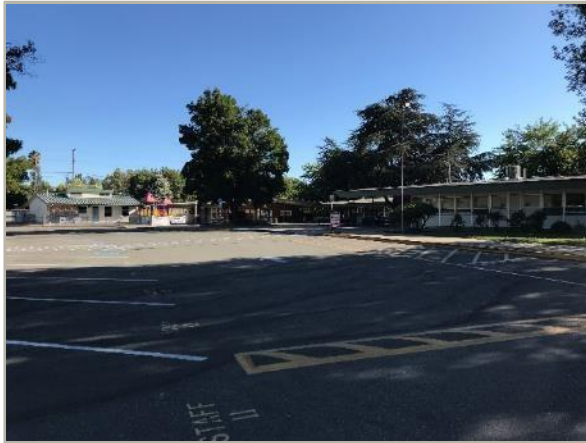
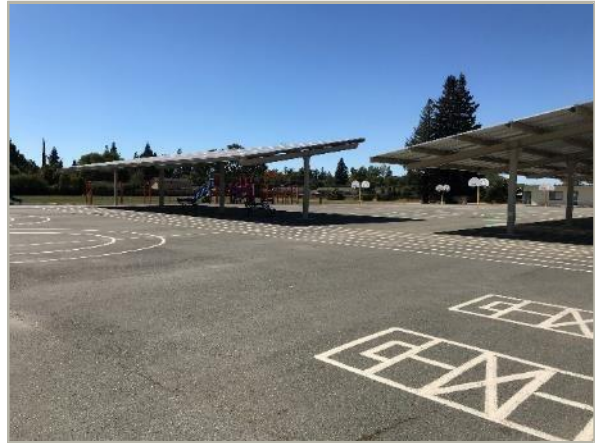
### Site Summary Information

| Site Information | | |
|---|---|---|
| <b>Key Issues &amp; Findings</b> | Isolated asphalt and concrete spalling | |
