## Westwood Elementary School

### OVERVIEW

#### **Property Executive Summary**

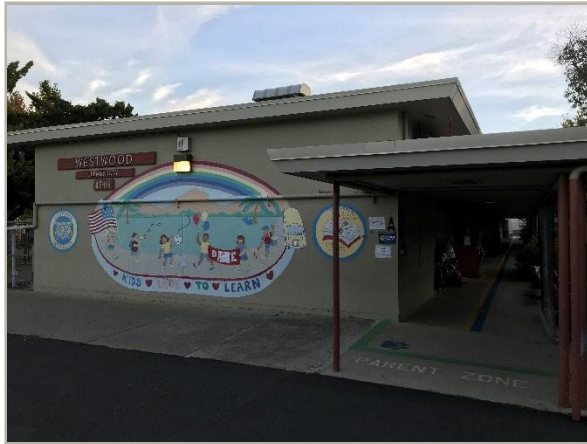
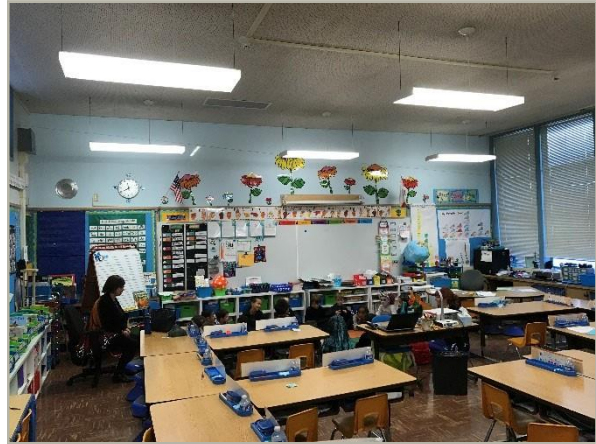
| Building Type 1 Information | | |
|---|---|---|
| <b>Key Issues &amp; Findings</b> | Building lacks complete fire suppression coverage | |

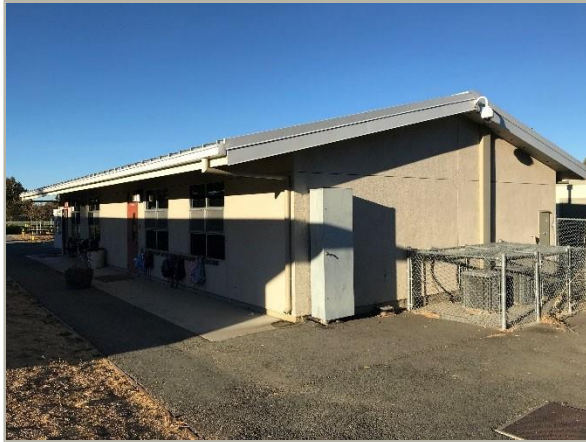
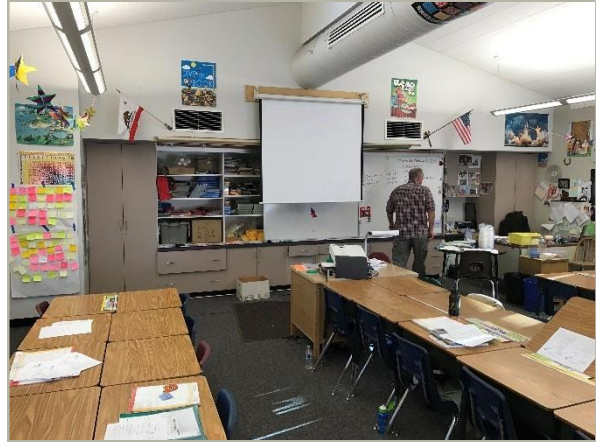
| Building Type 2 Information | | |
|---|---|---|
| <b>Key Issues &amp;<br/>Findings</b> | Buildings lack fire suppression | |

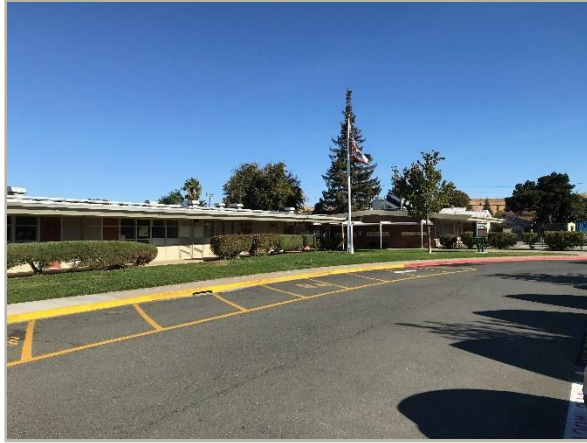
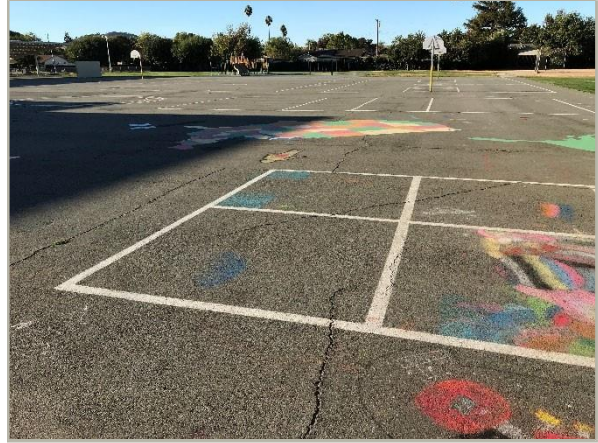
| Site Information | | |
|---|---|---|
| <b>Key Issues &amp; Findings</b> | Isolated uneven brick paving | |
