## Mt Diablo Elementary School

#### **Property Executive Summary**

### ASSESSMENT OF SITE

### Summary of Findings

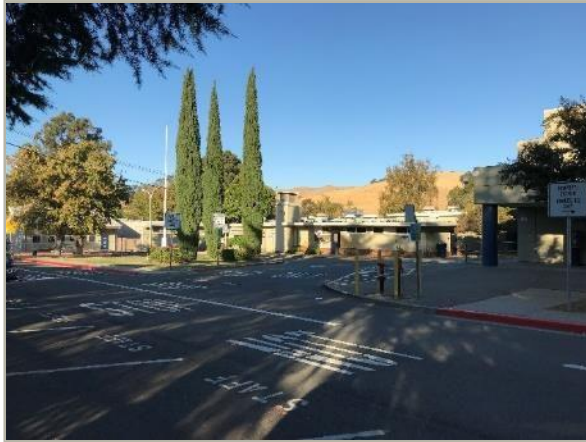
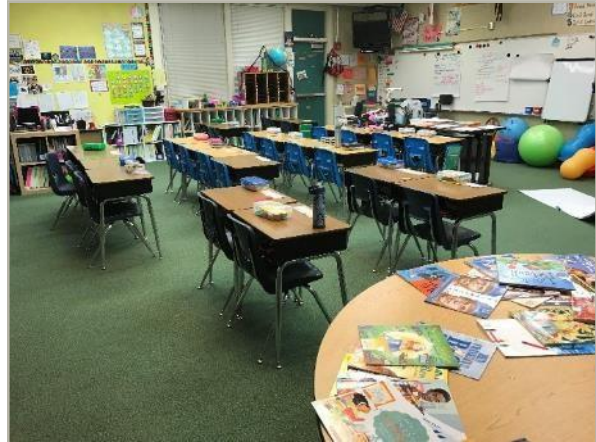
| Building Type 1 Information | | |
|---|---|---|
| <b>Key Issues &amp; Findings</b> | Buildings lack fire suppression except M-U stage | |

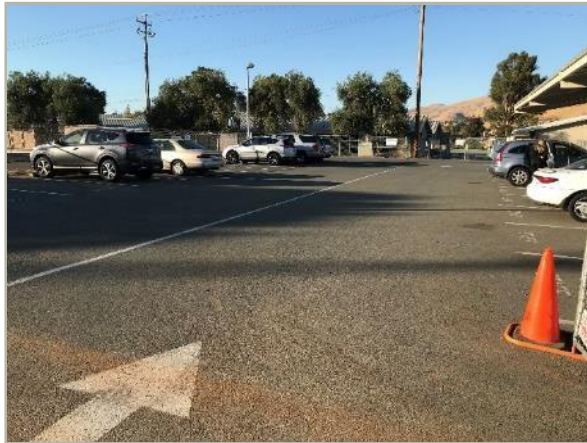
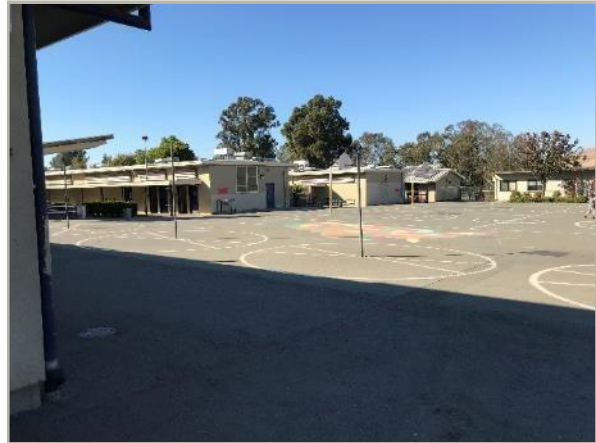
| Site Information | | |
|---|---|---|
| <b>Key Issues &amp; Findings</b> | The field is currently being renovated | |
