## Valhalla Elementary School

### OVERVIEW

### Summary of Findings

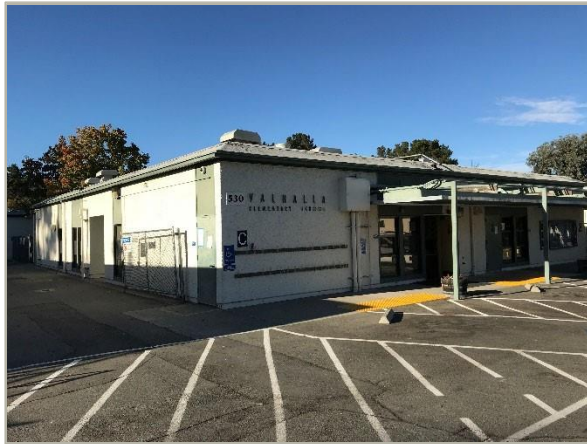
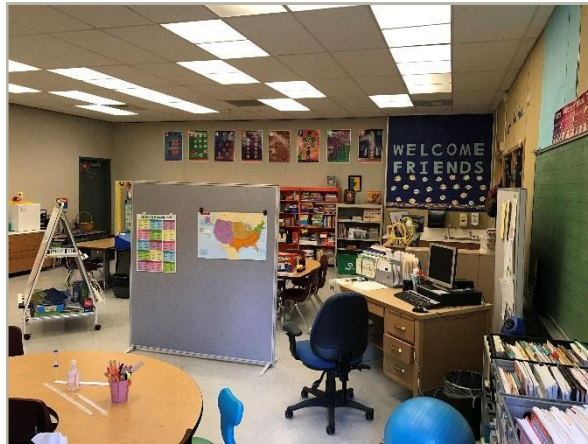
### Building Type 1 Information

| Building Type 1 Information | | |
|---|---|---|
| <b>Key Issues &amp; Findings</b> | Buildings lack complete fire suppression | |

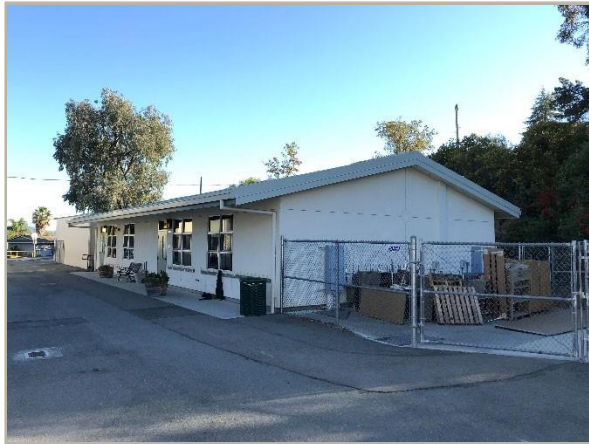
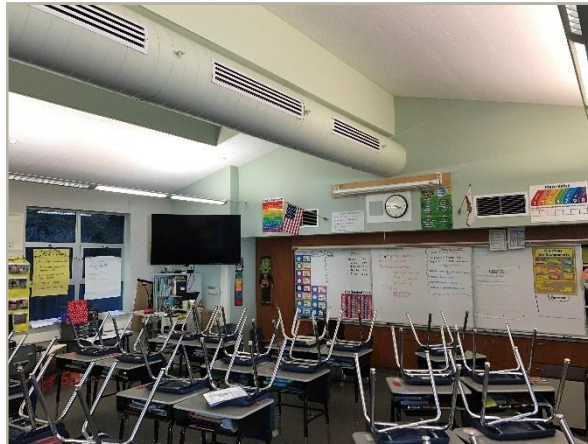
### Building Type 2 Information

| Building Type 2 Information | | |
|---|---|---|
| <b>Key Issues &amp; Findings</b> | Buildings lack fire suppression | |

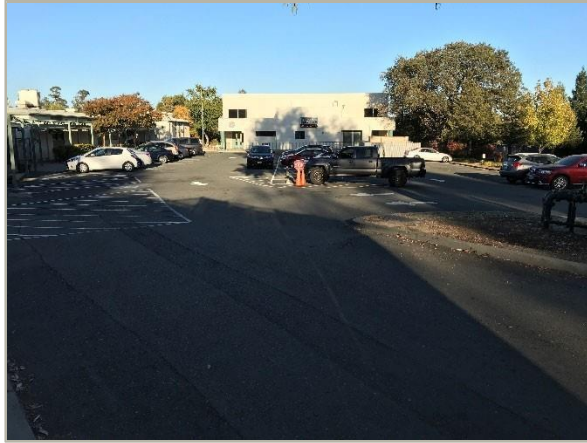
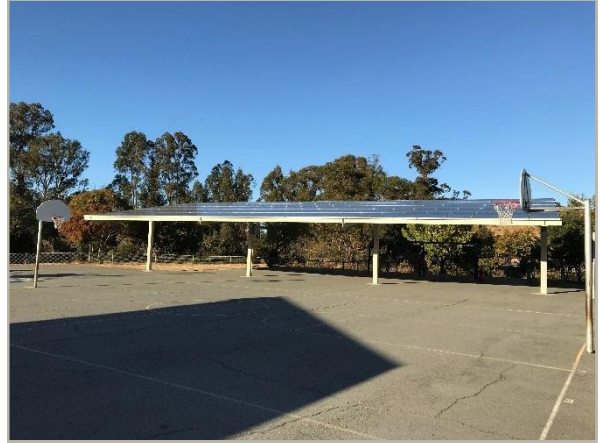
### Site Summary Information

| Site Information | | |
|---|---|---|
| <b>Key Issues &amp; Findings</b> | Significant running track unevenness, inadequate site lighting | |
