## Sequoia Elementary School

### EXISTING SITE INFORMATION

| Items | | Description |
|---|---|---|
| Project Name | | Sequoia Elementary School |

### Property Condition

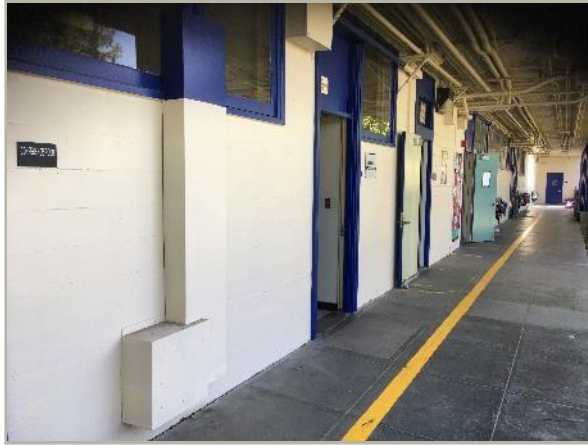
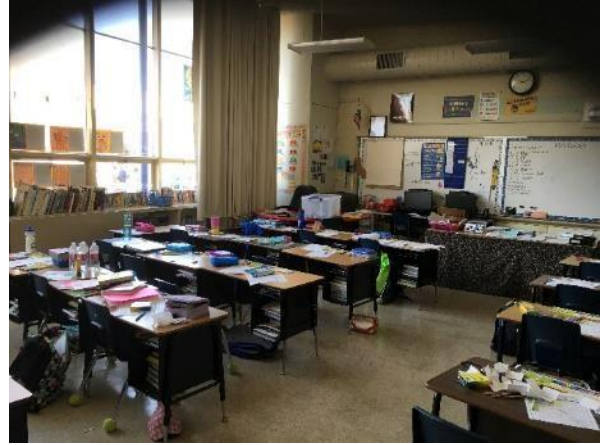
### Building Type 1 Information

| Building Type 1 Information | | |
|---|---|---|
| Key Issues & Findings | Building lacks fire suppression, worn or missing door sweeps/weather-stripping | |

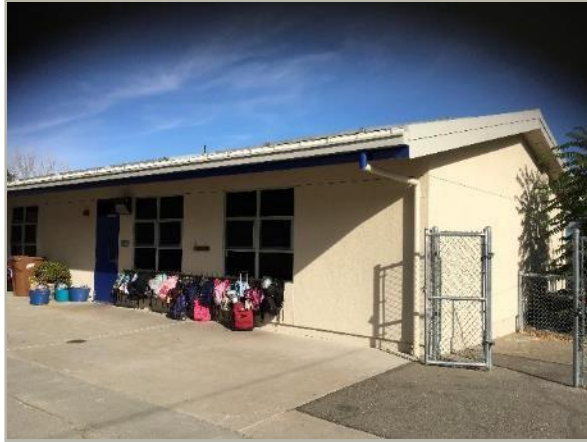
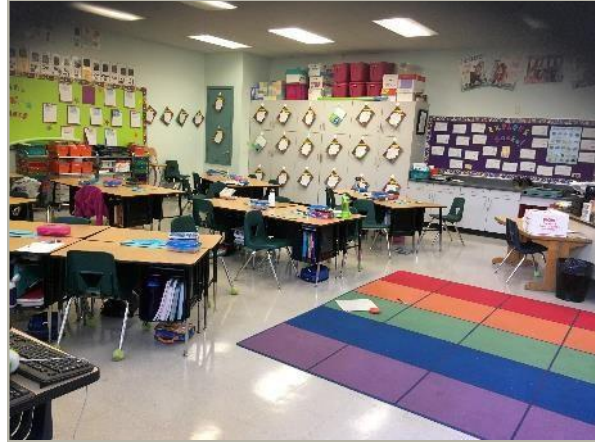
### Building Type 2 Information

| Building Type 2 Information | | |
|---|---|---|
| <b>Key Issues &amp; Findings</b> | Building lacks fire suppression | |

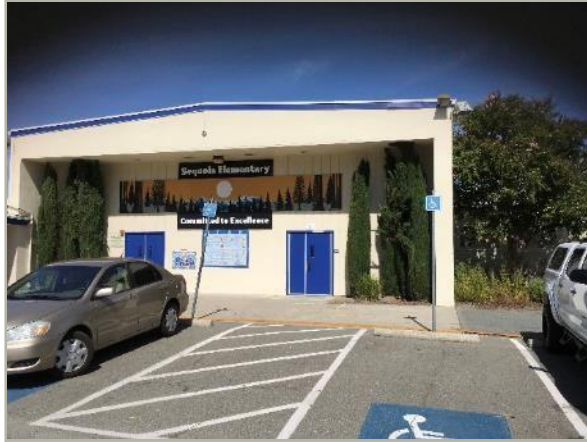
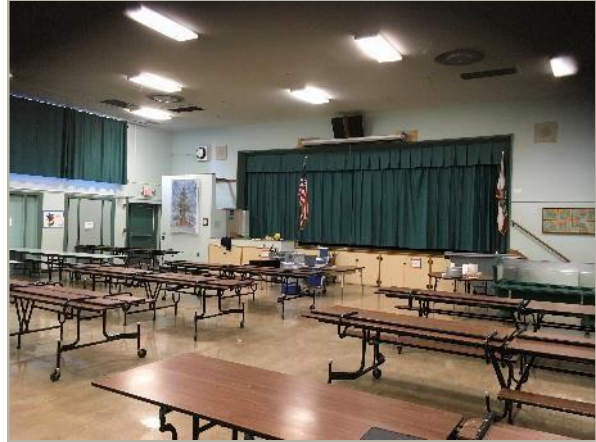
### Building Type 3 Information

| Building Type 3 Information | | |
|---|---|---|
| <b>Key Issues &amp; Findings</b> | Loose window screens in kitchen, materials and equipment left on roof from roofing contractor, broken conduits and fittings on roof from roofing project, unlevel rooftop unit above kitchen, building lacks fire suppression including kitchen hood | |

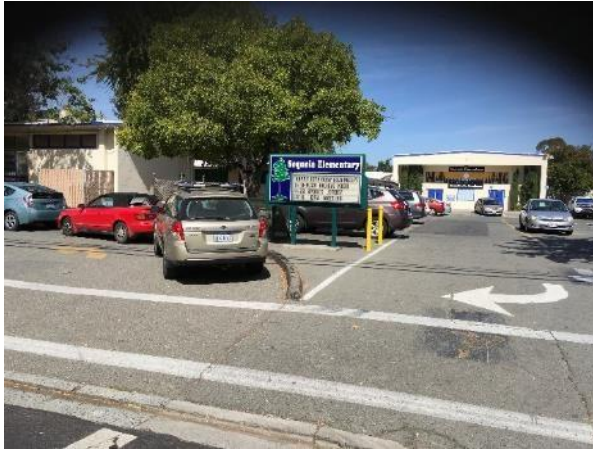
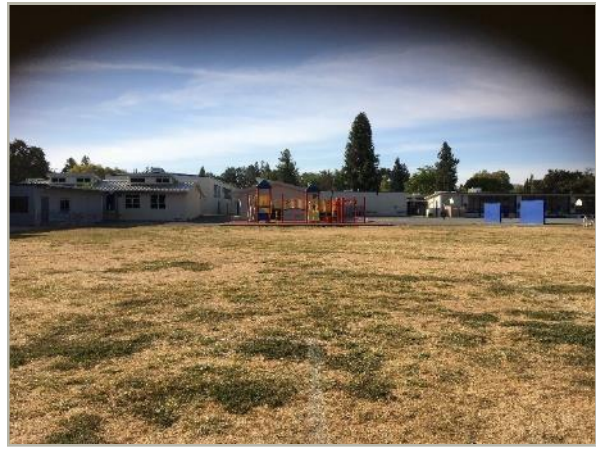
### Site Summary Information

| Site Information | | |
|---|---|---|
| <b>Key Issues &amp; Findings</b> | Trip hazards near some trees that have grown near asphalt, small area of missing landscaping brick near main entrance | |
