## Hidden Valley Elementary School

### OVERVIEW

#### **Property Executive Summary**

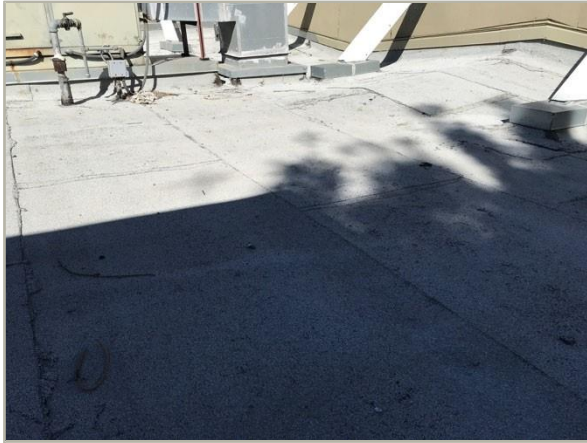
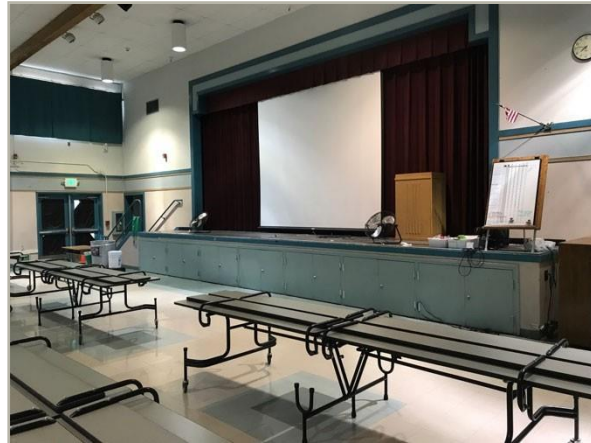
### Multiuse Building Information

| Multipurpose Building Information | | |
|---|---|---|
| <b>Roof</b> | Primary: Flat construction with modified bituminous finish | Poor |
| <b>Key Issues &amp; Findings</b> | Roof is in poor condition | |
