## El Monte Elementary School

### EXISTING SITE INFORMATION

### Property Condition

This report represents summary-level findings for the Property Condition Assessment. The deficiencies identified in this assessment can be combined with potential new construction requirements to develop an overall Long-Term Capital Needs Plan that can be the basis for a facility wide capital improvement funding strategy. Key findings from the Assessment include:

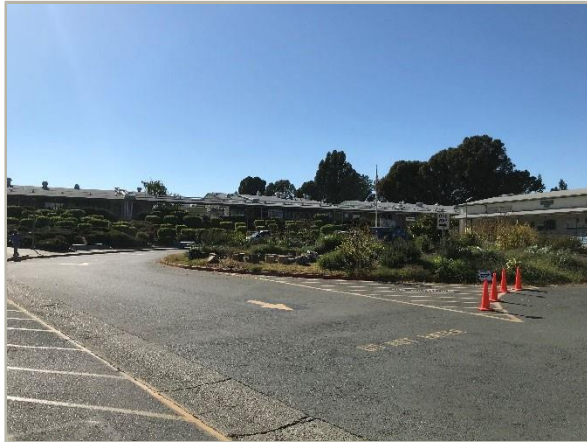
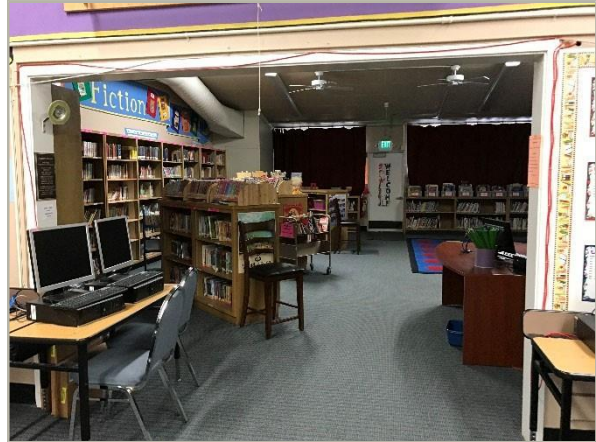
### Building Type 1 Information

| Building Type 1 Information | | |
|---|---|---|
| <b>Key Issues &amp; Findings</b> | Buildings lacks fire suppression. | |
