## Wren Elementary School

### OVERVIEW

#### Property Executive Summary

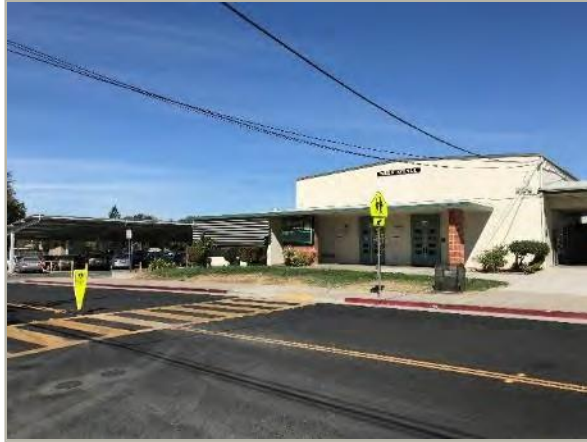
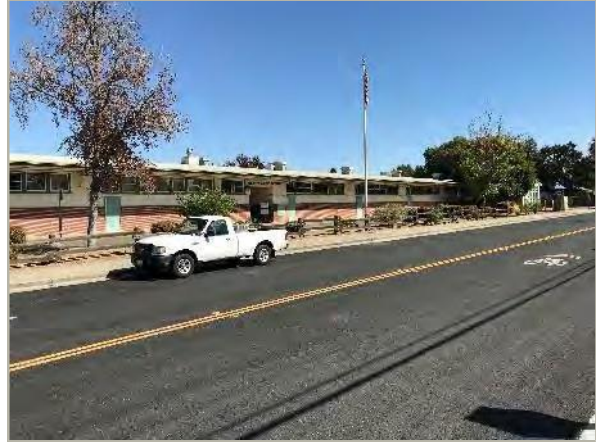
| Building Type 1 Information | | |
|---|---|---|
| <b>Key Issues &amp; Findings</b> | Possible structural settlement, antiquated HVAC components and infrastructure in M-U portion, building lacks fire suppression, possible ACM flooring | |

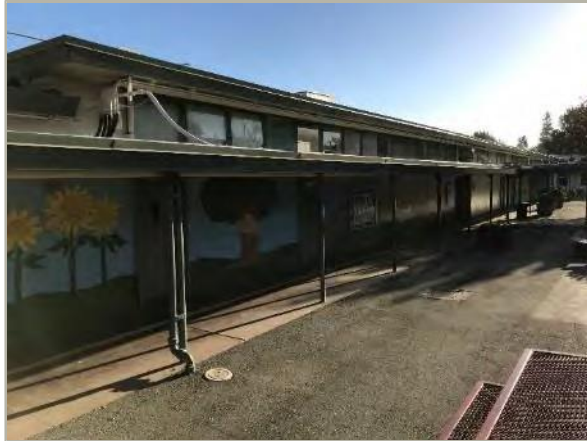
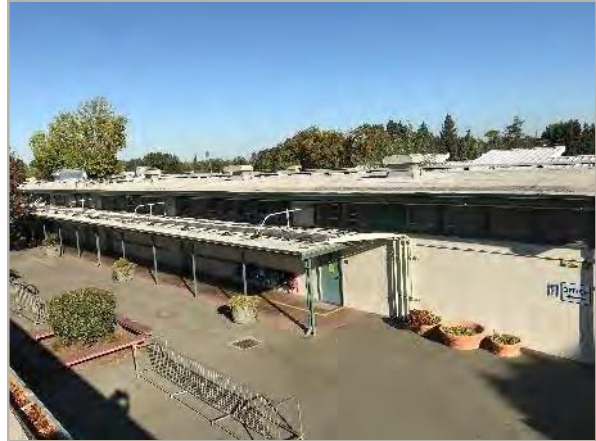
| Building Type 2 Information | | |
|---|---|---|
| <b>Key Issues &amp; Findings</b> | Possible structural settlement, antiquated windows, roof lacks drain baskets, possible ACM flooring | |

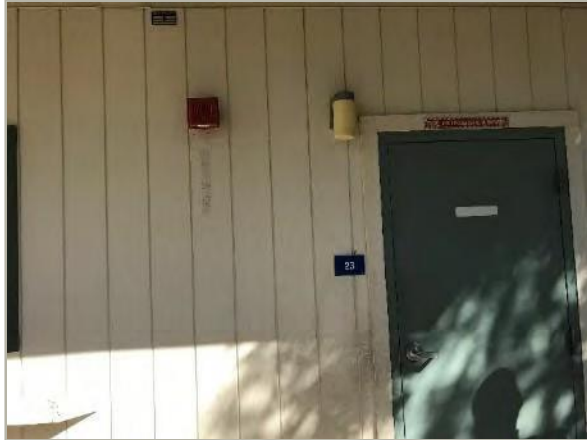
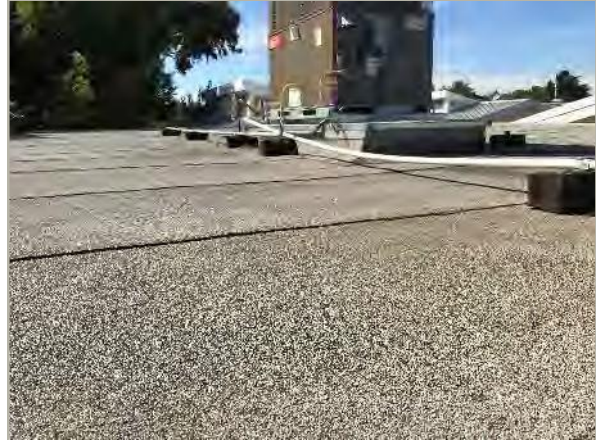
| Building Type 3 Information | | |
|---|---|---|
| <b>Key Issues &amp; Findings</b> | Package unit replaced very recently | |

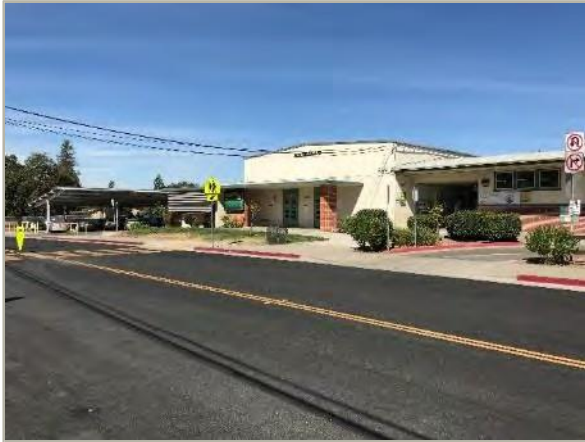
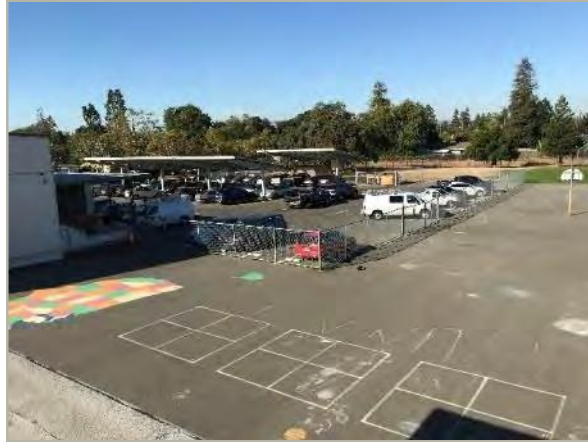
| Site Information | | |
|---|---|---|
| <b>Key Issues &amp; Findings</b> | Minor alligator cracking in parking lots and sidewalks | |
