## College Park High School

### OVERVIEW

#### **Property Executive Summary**

### Summary of Findings

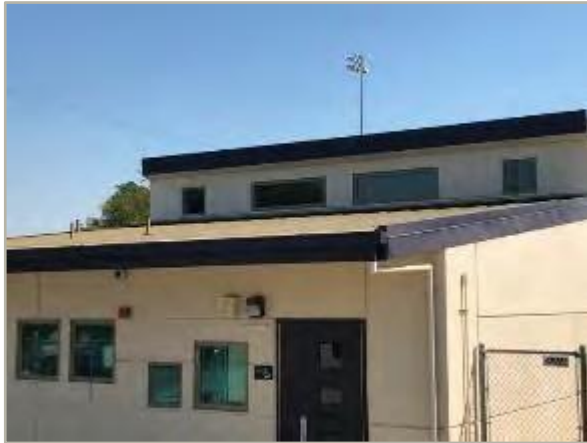
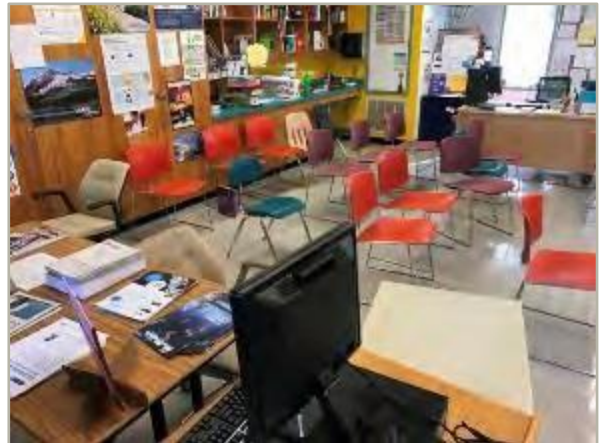
### Buildings S 6-7, S 8-9, S 10-11, S 12-14, S 15-16, S 17, S 18-19, S 20-21, S Restroom Information

| Buildings S 6-7, S 8-9, S 10-11, S 12-14, S 15-16, S 17, S 18-19, S 20-21, S Restroom<br>Information | | |
|---|---|---|
| <b>Key Issues &amp;<br/>Findings</b> | Electrical outlets in the S14 class room on the floor are plugged with a mixture of floor wax and dirt, creating a safety hazard | |

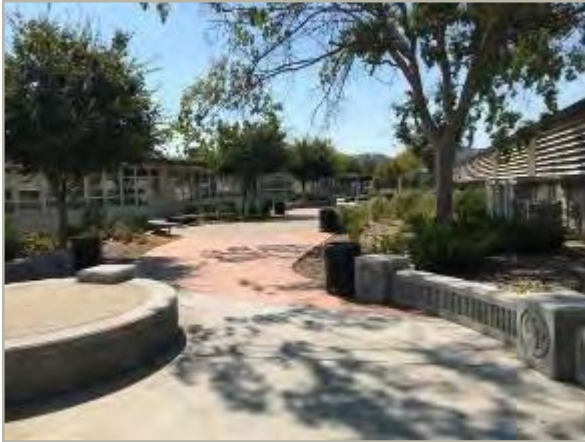
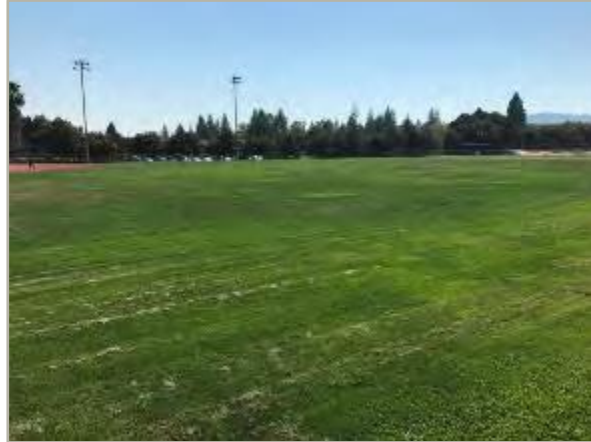
### Site Summary Information

| Site Information | | |
|---|---|---|
| <b>Draining Systems and Erosion Control</b> | Surface flow, Inlets, Underground piping, municipal system<br>The site drainage has a history of back-ups and clogs. | Fair |
| <b>Key Issues &amp; Findings</b> | Site drainage issues, especially near C wing. | |
