## Silverwood Elementary School

#### **Property Executive Summary**

Silverwood Elementary School is a fully-occupied academic campus. The buildings are single-story structures of varying ages. Overall, the buildings appear to be in good condition. The HVAC systems were upgraded in 2014. Electrical systems were upgraded in 2002. The exterior windows are older, single-glazed units that are thermally inefficient.

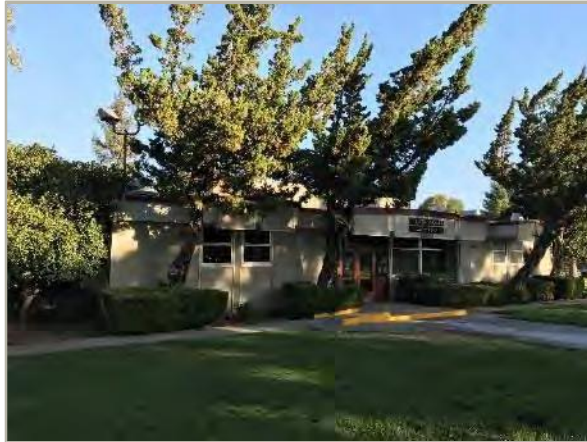
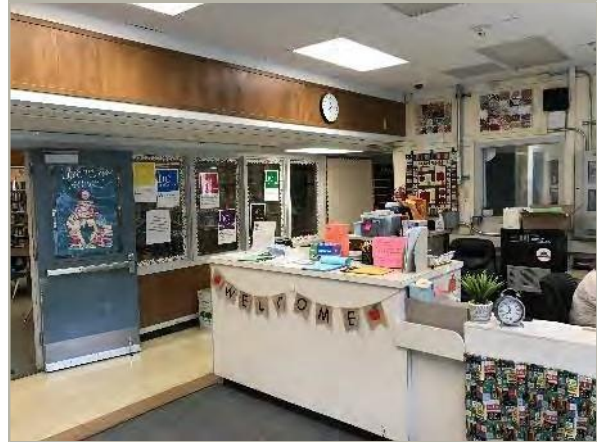
| Building Type 1 Information | | |
|---|---|---|
| <b>Key Issues &amp; Findings</b> | Limited fire suppression system coverage | |

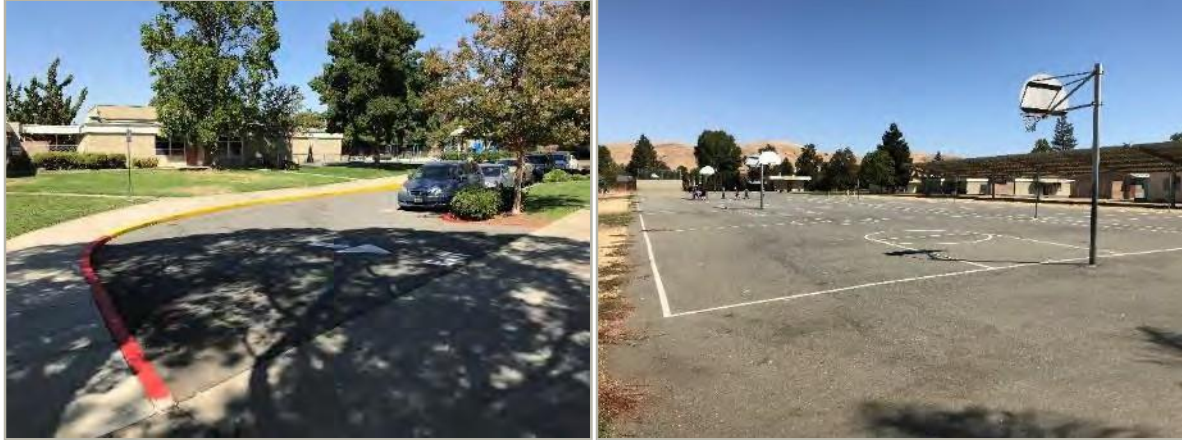
| Site Information | | |
|---|---|---|
| <b>Key Issues &amp; Findings</b> | Inadequate site lighting | |
