## Mountain View Elementary School

### OVERVIEW

### Summary of Findings

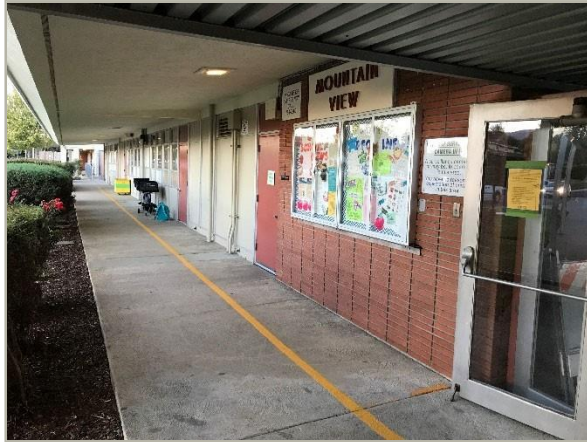
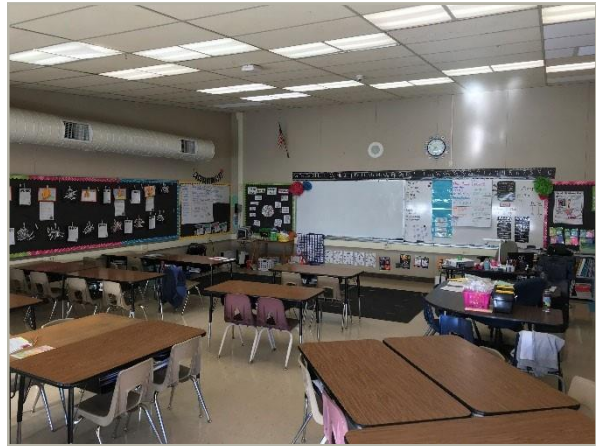
### Building Type 1 Information

| Building Type 1 Information | | |
|---|---|---|
| <b>Key Issues &amp; Findings</b> | Classroom leaking faucet and building lacks complete fire suppression coverage | |

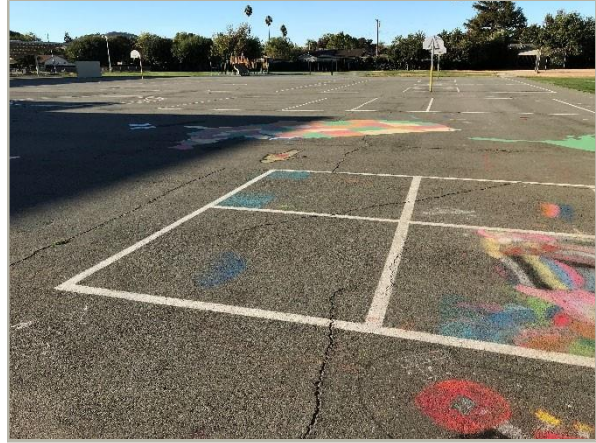
### Site Summary Information

| Site Information | | |
|---|---|---|
| <b>Key Issues &amp; Findings</b> | Isolated uneven brick paving | |
