## Meadow Homes Elementary School

### OVERVIEW

### Summary of Findings

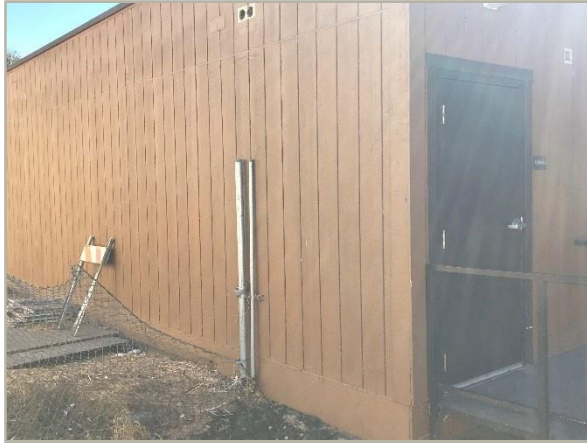
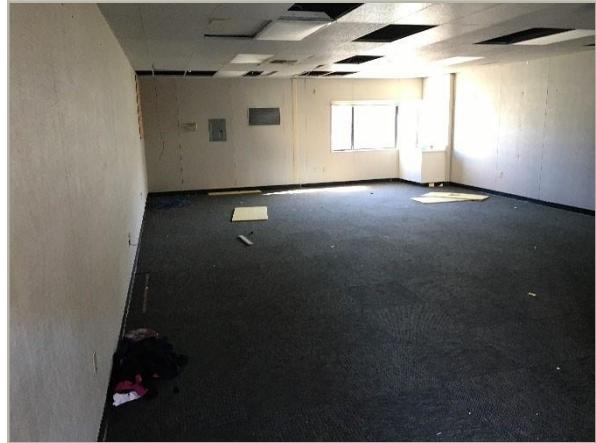
| Building Type 2 Information | | |
|---|---|---|
| <b>Interiors</b> | Walls: Covered gypsum board<br>Floors: Carpet<br>Ceilings: ACT | Poor |
| <b>Key Issues &amp; Findings</b> | No fire suppression or alarm in either building. ACT needs to be repaired/replaced. | |
