### Delta View Elementary School

## Delta View Elementary School

### ASSESSMENT OF SITE

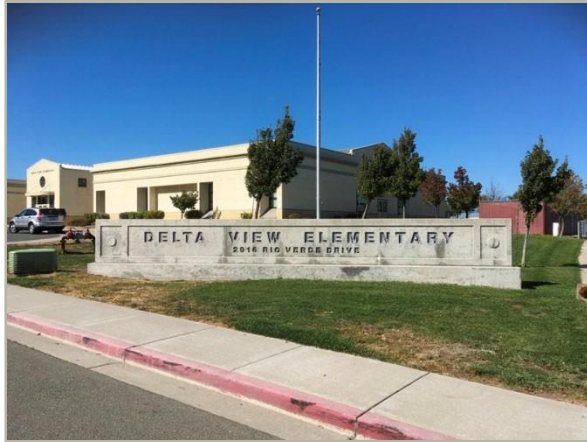
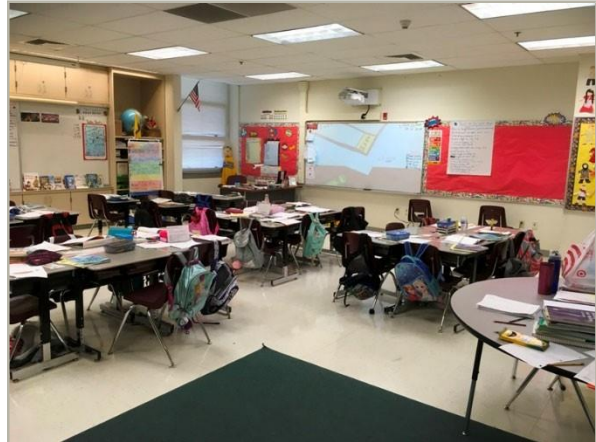
The parking lot is in good condition with minimal deficiencies. Parking spaces are well marked. There are isolated areas of asphalt damage due to tree root overgrowth in the parking lot and kindergarten play area. Sidewalk concrete is in good condition with no major deficiencies. Trees and shrubs are well maintained. Grass is well maintained in irrigated areas, but the commons area ground cover—which is not irrigated—has mostly died over the years. Site lighting consists of wall- and pole-mounted fixtures.

| Site Information | | |
|---|---|---|
| <b>Key Issues &amp; Findings</b> | Asphalt damage due to tree growth in parking lot and kindergarten playground | |
