## Holbrook Elementary School

### OVERVIEW

#### Property Executive Summary

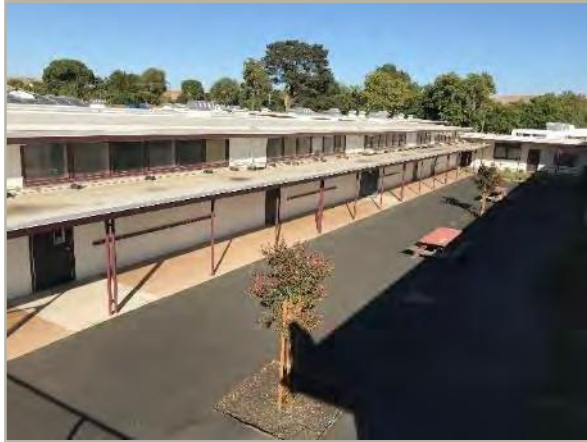
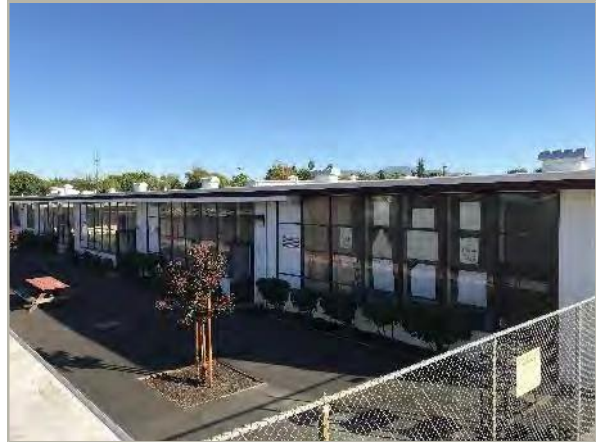
### Original Wings Information

| Original Wings Information | | |
|---|---|---|
| <b>Key Issues &amp; Findings</b> | Minor cracking in slabs, antiquated HVAC components and infrastructure (used in M-U, decommissioned elsewhere), buildings lack fire suppression, missing ADA pipe wraps in some classrooms | |

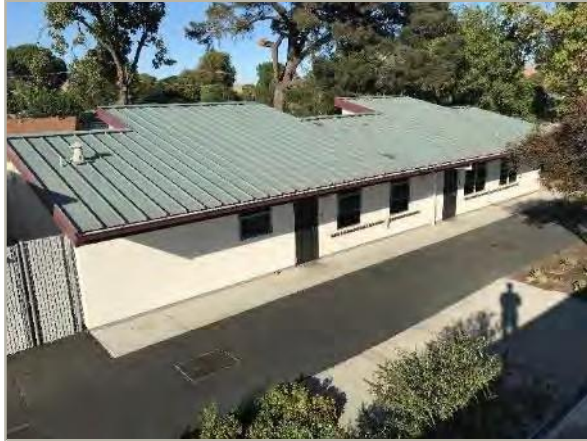
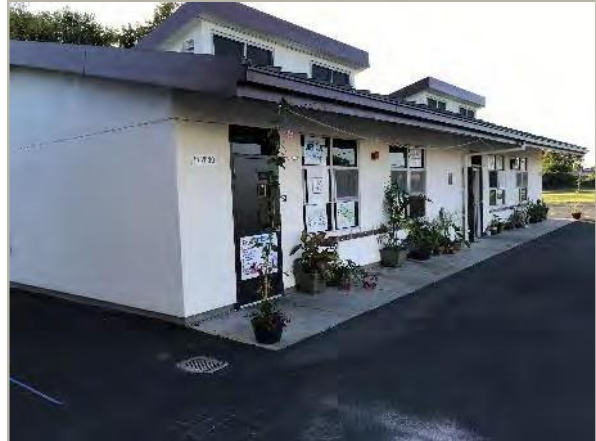
### Emily Building Information

| Emily Building Information | | |
|---|---|---|
| <b>Key Issues &amp;<br/>Findings</b> | Aged HVAC components | |

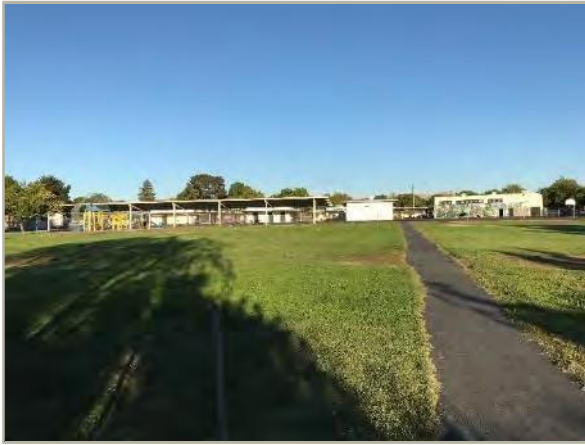
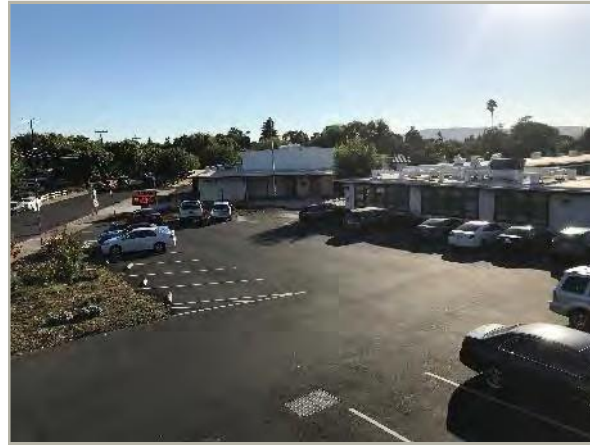
### Site Summary Information

| Site Information | | |
|---|---|---|
| <b>Key Issues &amp; Findings</b> | Minor alligator cracking, suboptimal but adequate site lighting | |
