# VARGAS ELEMENTARY SCHOOL

SUNNYVALE SCHOOL DISTRICT | FACILITIES MASTER PLAN 2022

# FACILITY CONDITION ASSESSMENT

May 14, 2021

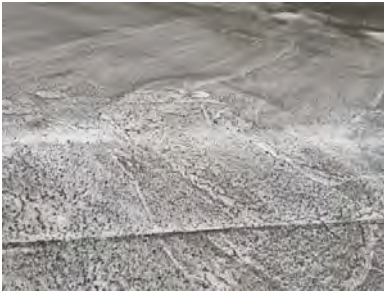
### Roofing in Poor condition.

Modified Bitumen  
Main Office Vargas School Roof

The roof is in poor condition. There are lots of bubbling and cracks observed throughout. - AssetCALC ID: 2006197

Unifomat Code: B3015  
Recommendation: **Replace in 2021**

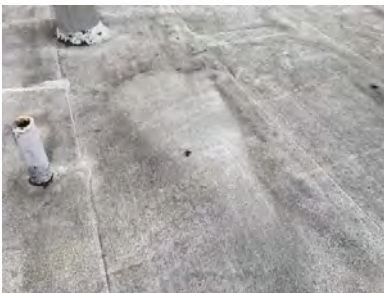
### Roofing in Poor condition.

Modified Bitumen  
Multipurpose/Classrooms 13-18 Vargas School Roof

The roof is in poor condition. Multiple bubbles on the underside of the roofs and cracks were observed. - AssetCALC ID: 2005919

Unifomat Code: B3015  
Recommendation: **Replace in 2021**

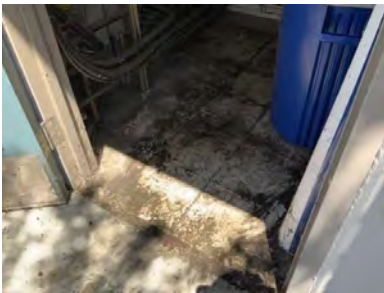
### Piping & Valves in Poor condition.

any type Drain Pipes, Water Jet Cleaning  
Classrooms 4-6 Vargas School Building 4-6 & 7-9

Furnace condensate drains are clogged, water is overflowing onto the mechanical room floor - AssetCALC ID: 2015352

Unifomat Code: G3032  
Recommendation: **Cleaning in 2021**

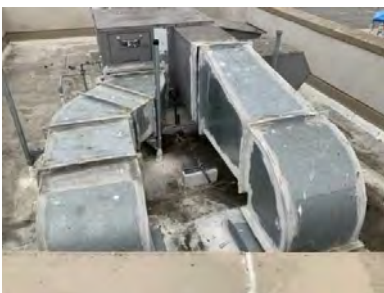
### HVAC System in Poor condition.

Ductwork, Medium Density  
Main Office Vargas School Building Main Office

It was reported by POC that ducting is poor and deteriorating - AssetCALC ID: 2015372

Unifomat Code: D3055  
Recommendation: **Replace in 2022**

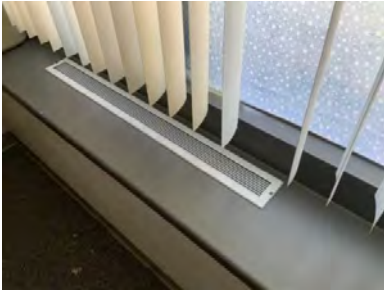
### HVAC System in Poor condition.

It was reported by POC that ducting is poor and deteriorating - AssetCALC ID: 2015237

Uniformat Code: D3055  
Recommendation: **Replace in 2022**

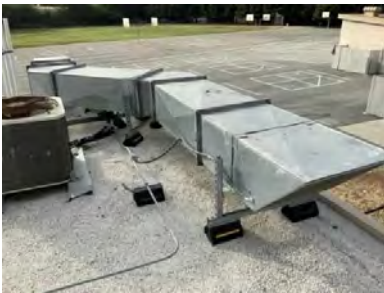
### HVAC System in Poor condition.

It was reported by POC that ducting is poor and deteriorating - AssetCALC ID: 2015310

Uniformat Code: D3055  
Recommendation: **Replace in 2022**

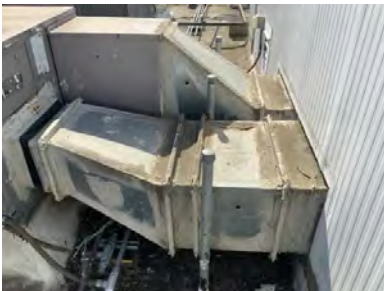
### HVAC System in Poor condition.

It was reported by POC that ducting is poor and deteriorating - AssetCALC ID: 2015232

Uniformat Code: D3055  
Recommendation: **Replace in 2022**

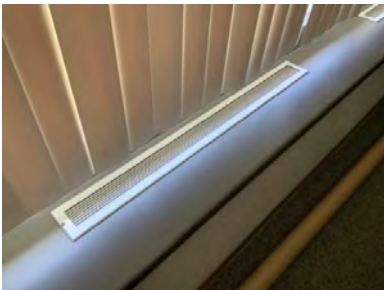
### HVAC System in Poor condition.

It was reported by POC that ducting is poor and deteriorating - AssetCALC ID: 2015404

Uniformat Code: D3055  
Recommendation: **Replace in 2022**

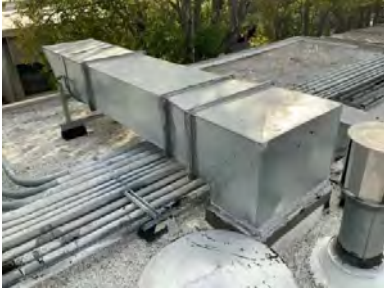
**HVAC System in Poor condition.**

Ductwork, Medium Density  
Classrooms K1-K2 Vargas School Building K1-K2

It was reported by POC that ducting is poor and deteriorating - AssetCALC ID: 2015346

Uniformat Code: D3055  
Recommendation: **Replace in 2022**

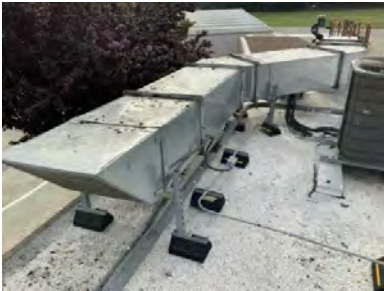
**HVAC System in Poor condition.**

Ductwork, Medium Density  
Classrooms 4-6 Vargas School Building 4-6

It was reported by POC that ducting is poor and deteriorating - AssetCALC ID: 2015380

Uniformat Code: D3055  
Recommendation: **Replace in 2022**
