**FACILITIES MASTER PLAN 2022**  
PLEASANTON UNIFIED SCHOOL DISTRICT

# **HARVEST PARK MIDDLE SCHOOL**

# FACILITY CONDITION ASSESSMENT

Harvest Park Middle School  
4900 Valley Avenue  
Pleasanton, California 94566

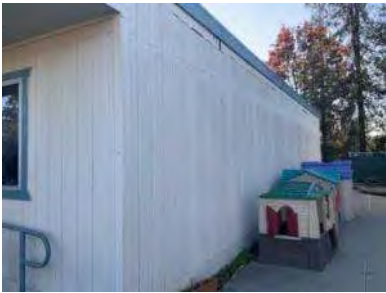
Exterior Walls in Poor condition.

any painted surface  
Portables Harvest Park Middle School  
Conference Portable

The paint on the exterior of the building is coming off and it is recommended to repaint. - AssetCALC ID: 3465220

Uniformat Code: B2010  
Recommendation: **Prep & Paint in 2022**
