# CHARGER PRIDE

SITE FUNCTIONALITY ASSESSMENT

## CHERRY CHASE ELEMENTARY SCHOOL

SUNNYVALE SCHOOL DISTRICT | FACILITIES MASTER PLAN 2022

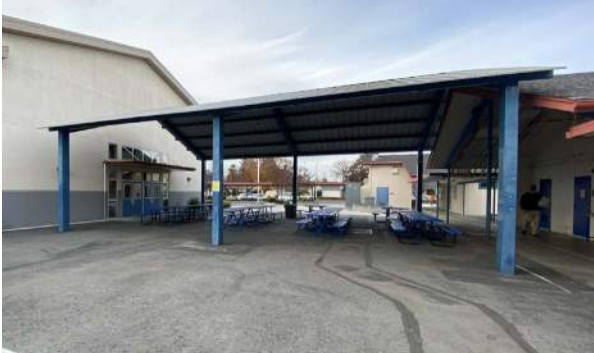
Shade Structure

Spaces between the finger wing buildings are fully paved in asphalt with minimal shade or landscaping.

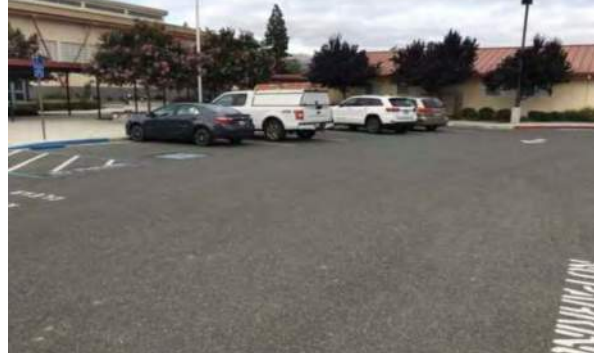
Drop-Off Lane / Parking

Parking is extremely limited on this site. The drop-off lane is short. The principal noted the desire for improved signage to improve traffic flow.

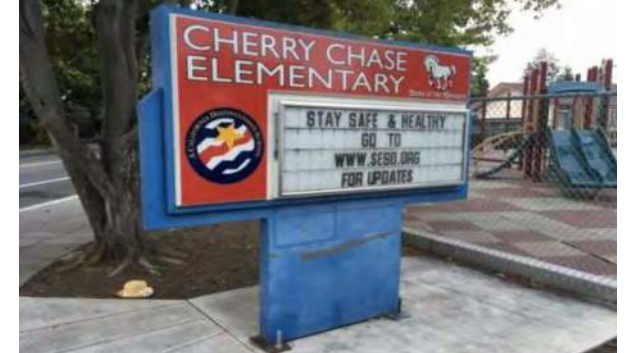
Site Identification and Announcements

The site has an analogue marquee sign at the school frontage.

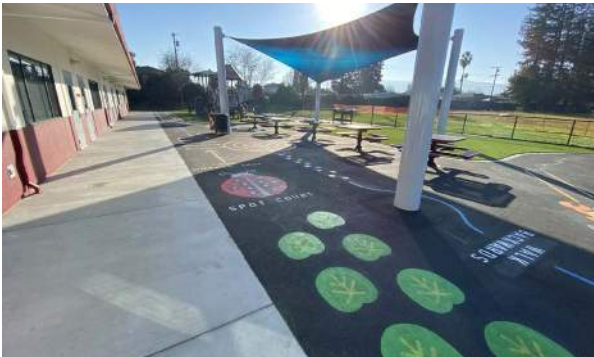
Kindergarten Play Yard

Play equipment and rubber surfacing are in new condition in the Kindergarten play yard and at the lower primary play area and hardcourts.

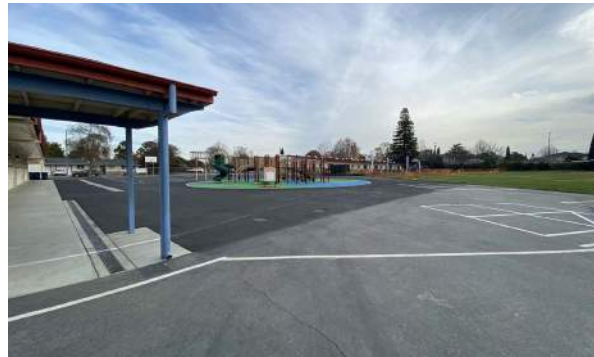
Hardcourts

The principal noted a need for new striping and basketball hoops.

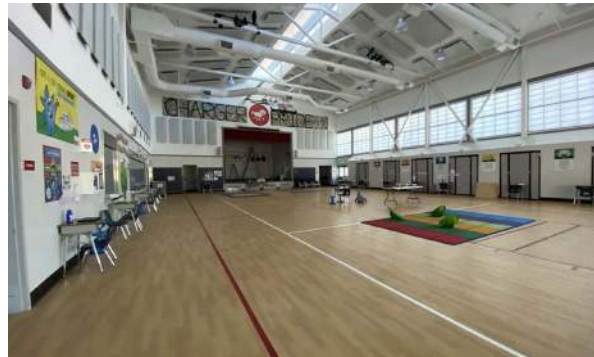
The Multi-Purpose Room is a shared community asset with a full-size basketball court with retractable backstops.

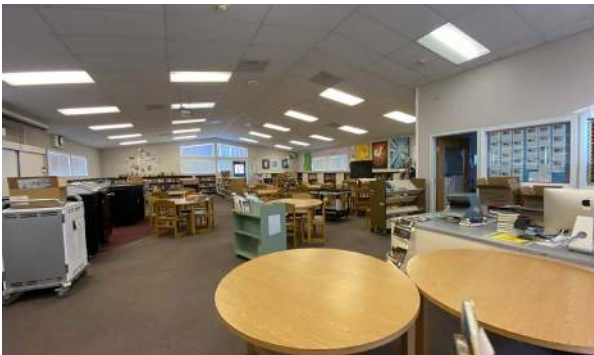
Library

The principal suggests modernization of this space with new furniture. Currently, the furniture consists of round tables with chairs, all made of heavy wood. Book stacks are low and appropriately sized for the age group.

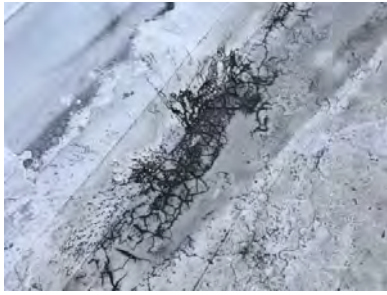
**Roofing in Poor condition.**

Single-Ply Membrane, TPO/PVC  
Multi-Use Building Cherry Chase Elementary  
School Roof

Roofing is worn, cracked, and blistering - AssetCALC ID: 2001078

Uniformat Code: B3015  
Recommendation: **Replace in 2021**

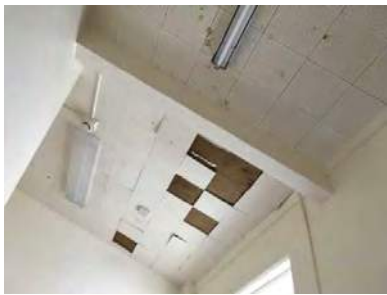
**Suspended Ceilings in Poor condition.**

Hard Tile, Replacement w/ ACT  
Classrooms 12-15 Cherry Chase Elementary  
School Restrooms

Tiles are stained and falling off - AssetCALC ID: 2001220

Uniformat Code: C1071  
Recommendation: **Replace in 2022**
