# FAIRWOOD EXPLORER ELEMENTARY SCHOOL

SUNNYVALE SCHOOL DISTRICT | FACILITIES MASTER PLAN 2022

# FACILITY CONDITION ASSESSMENT

Fairwood Explorer Elementary School  
1110 Fairwood Avenue  
Sunnyvale, California 94089

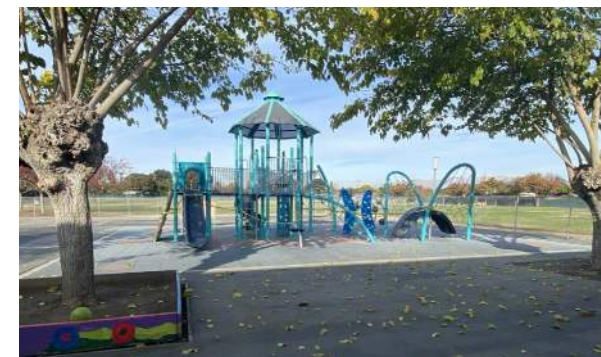
Play Structure

Upper and Lower Primary play areas are separated by the main classroom building. While the play structures have been renovated, the rubber surfacing needs to be redone.

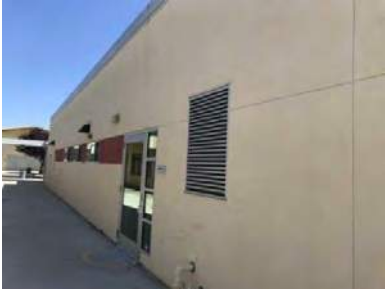
### Exterior Walls in Poor condition.

Insulated Finishing System (EIFS), 1-2 Story Building  
G-Media Center Fairwood Explorer Elementary School Building exterior

Cracking - AssetCALC ID: 1996932

Uniformat Code: B2011  
Recommendation: **Replace in 2022**

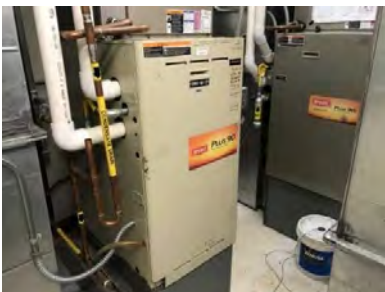
### Furnace in Poor condition.

Gas  
B-Administration/Kindergarten Fairwood Explorer Elementary School Mechanical room

End of useful life - AssetCALC ID: 1996884

Uniformat Code: D3021  
Recommendation: **Replace in 2021**

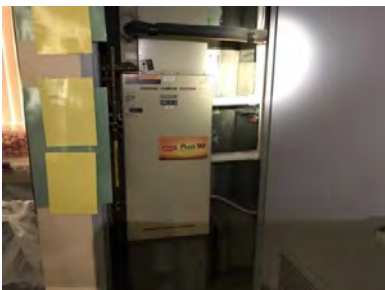
### Furnace in Poor condition.

Gas  
B-Administration/Kindergarten Fairwood Explorer Elementary School Mechanical room

At the end of expected useful life - AssetCALC ID: 1996952

Uniformat Code: D3021  
Recommendation: **Replace in 2021**

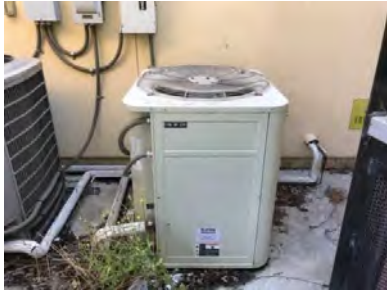
### Split System in Poor condition.

Condensing Unit/Heat Pump  
B-Administration/Kindergarten Fairwood  
Explorer Elementary School Building exterior

Well past expected useful life - AssetCALC ID: 1996895

Recommendation: **Replace in 2021**

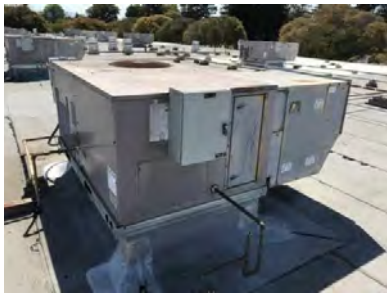
### Packaged Unit in Poor condition.

RTU, Pad or Roof-Mounted  
C-Classrooms Fairwood Explorer Elementary  
School Roof

At the end of useful life - AssetCALC ID: 1996844

Recommendation: **Replace in 2021**

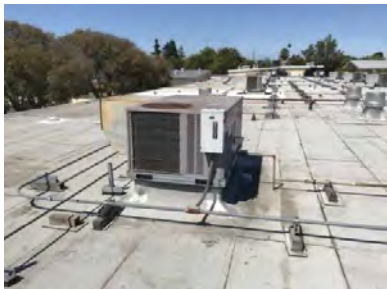
### Packaged Unit in Poor condition.

RTU, Pad or Roof-Mounted  
C-Classrooms Fairwood Explorer Elementary  
School Roof

At the end of useful life - AssetCALC ID: 1996843

Recommendation: **Replace in 2021**

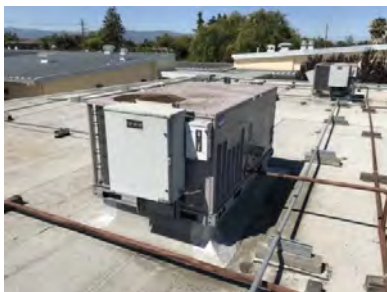
### Packaged Unit in Poor condition.

RTU, Pad or Roof-Mounted  
C-Classrooms Fairwood Explorer Elementary  
School Roof

Well past the end of useful life - AssetCALC ID: 1996914

Recommendation: **Replace in 2021**

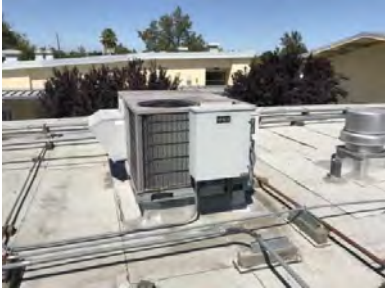
### Packaged Unit in Poor condition.

RTU, Pad or Roof-Mounted  
C-Classrooms Fairwood Explorer Elementary  
School Roof

Well past the end of useful life - AssetCALC ID: 1996849

Uniformat Code: D3055  
Recommendation: **Replace in 2021**

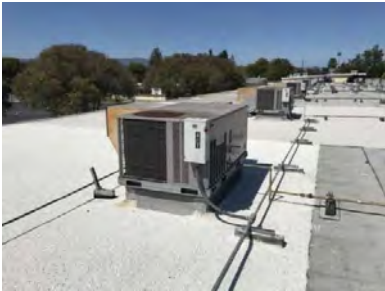
### Packaged Unit in Poor condition.

RTU, Pad or Roof-Mounted  
C-Classrooms Fairwood Explorer Elementary  
School Roof

At the end of useful life - AssetCALC ID: 1996837

Uniformat Code: D3055  
Recommendation: **Replace in 2021**

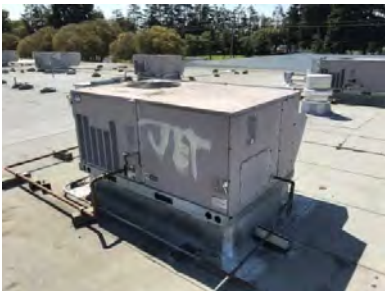
### Packaged Unit in Poor condition.

RTU, Pad or Roof-Mounted  
C-Classrooms Fairwood Explorer Elementary  
School Roof

Well past expected useful life - AssetCALC ID: 1996847

Uniformat Code: D3055  
Recommendation: **Replace in 2021**

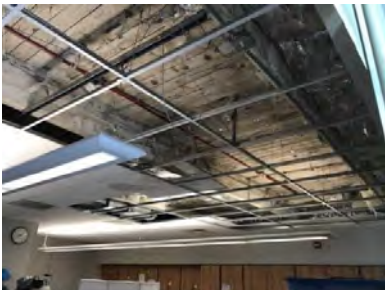
### Suspended Ceilings in Poor condition.

Acoustical Tile (ACT)  
C-Classrooms Fairwood Explorer Elementary  
School Room 10

Leaks caused damage to suspended ACT tiles. - AssetCALC ID: 1996934

Uniformat Code: C1071  
Recommendation: **Replace in 2021**

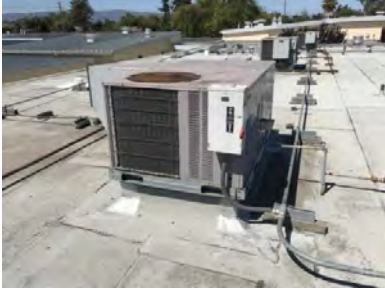
### Packaged Unit in Poor condition.

RTU, Pad or Roof-Mounted  
C-Classrooms Fairwood Explorer Elementary  
School Roof

At the end of useful life - AssetCALC ID: 1996846

Uniformat Code: D3055  
Recommendation: **Replace in 2021**

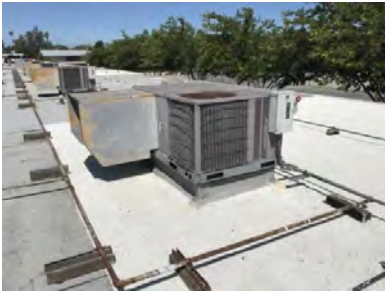
### Packaged Unit in Poor condition.

RTU, Pad or Roof-Mounted  
C-Classrooms Fairwood Explorer Elementary  
School Roof

At the end of useful life - AssetCALC ID: 1996967

Uniformat Code: D3055  
Recommendation: **Replace in 2021**

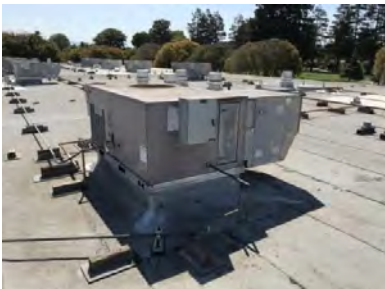
### Packaged Unit in Poor condition.

RTU, Pad or Roof-Mounted  
C-Classrooms Fairwood Explorer Elementary  
School Roof

At the end of useful life - AssetCALC ID: 1996890

Uniformat Code: D3055  
Recommendation: **Replace in 2021**

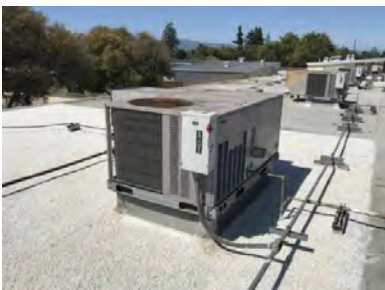
### Packaged Unit in Poor condition.

RTU, Pad or Roof-Mounted  
C-Classrooms Fairwood Explorer Elementary  
School Roof

At the end of useful life - AssetCALC ID: 1996858

Uniformat Code: D3055  
Recommendation: **Replace in 2021**

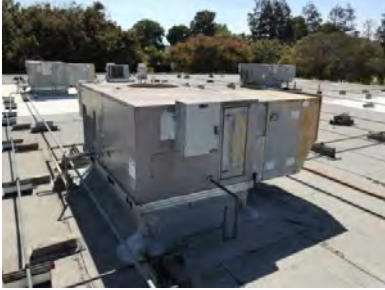
### Packaged Unit in Poor condition.

RTU, Pad or Roof-Mounted  
C-Classrooms Fairwood Explorer Elementary  
School Roof

At the end of useful life - AssetCALC ID: 1996830

Uniformat Code: D3055  
Recommendation: **Replace in 2021**

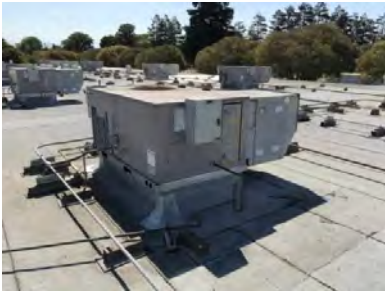
### Packaged Unit in Poor condition.

RTU, Pad or Roof-Mounted  
C-Classrooms Fairwood Explorer Elementary  
School Roof

At the end of useful life - AssetCALC ID: 1996879

Uniformat Code: D3055  
Recommendation: **Replace in 2021**

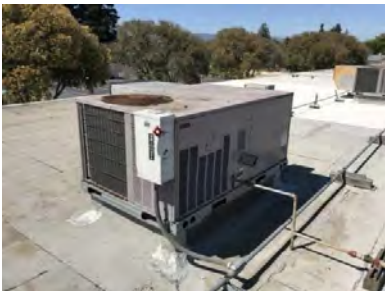
### Packaged Unit in Poor condition.

RTU, Pad or Roof-Mounted  
C-Classrooms Fairwood Explorer Elementary  
School Roof

At the end of useful life - AssetCALC ID: 1996902

Uniformat Code: D3055  
Recommendation: **Replace in 2021**

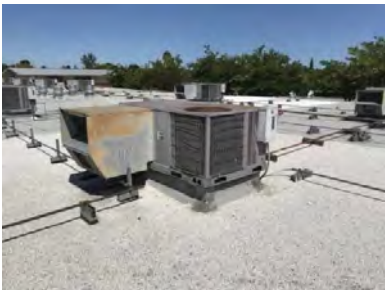
### Packaged Unit in Poor condition.

RTU, Pad or Roof-Mounted  
C-Classrooms Fairwood Explorer Elementary  
School Roof

At the end of useful life - AssetCALC ID: 1996962

Uniformat Code: D3055  
Recommendation: **Replace in 2021**

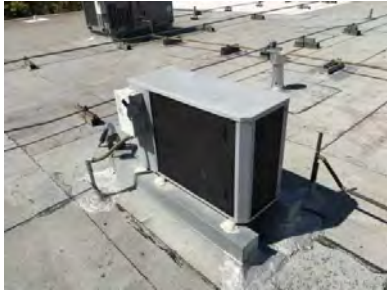
### Split System in Poor condition.

Condensing Unit/Heat Pump  
C-Classrooms Fairwood Explorer Elementary  
School Roof

Heavily weathered. - AssetCALC ID: 1996917

Recommendation: **Replace in 2021**

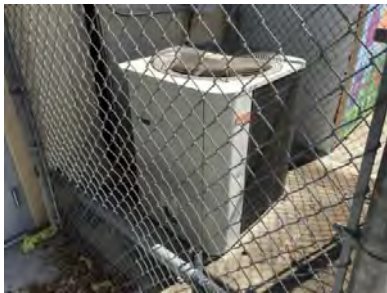
### Split System in Poor condition.

Condensing Unit/Heat Pump  
B-Administration/Kindergarten Fairwood  
Explorer Elementary School Building exterior

Well past expected useful life - AssetCALC ID: 1996976

Recommendation: **Replace in 2021**

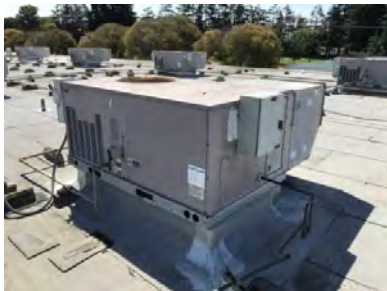
### Packaged Unit in Poor condition.

RTU, Pad or Roof-Mounted  
C-Classrooms Fairwood Explorer Elementary  
School Roof

At the end of expected useful life - AssetCALC ID: 1996888

Recommendation: **Replace in 2021**

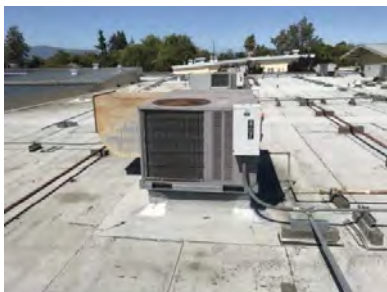
### Packaged Unit in Poor condition.

RTU, Pad or Roof-Mounted  
C-Classrooms Fairwood Explorer Elementary  
School Roof

At the end of useful life - AssetCALC ID: 1996870

Recommendation: **Replace in 2021**

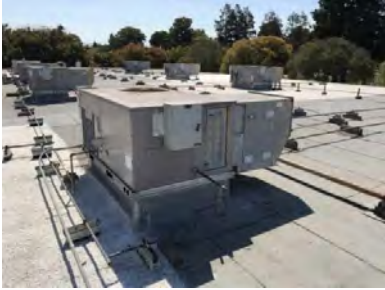
### Packaged Unit in Poor condition.

RTU, Pad or Roof-Mounted  
C-Classrooms Fairwood Explorer Elementary  
School Roof

At the end of useful life - AssetCALC ID: 1996957

Uniformat Code: D3055  
Recommendation: **Replace in 2021**

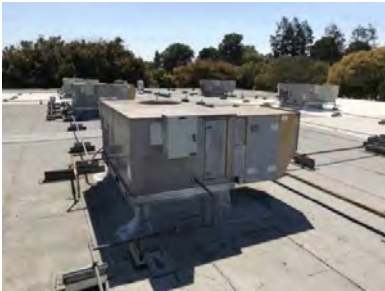
### Packaged Unit in Poor condition.

RTU, Pad or Roof-Mounted  
C-Classrooms Fairwood Explorer Elementary  
School Roof

At the end of useful life - AssetCALC ID: 1996990

Uniformat Code: D3055  
Recommendation: **Replace in 2021**

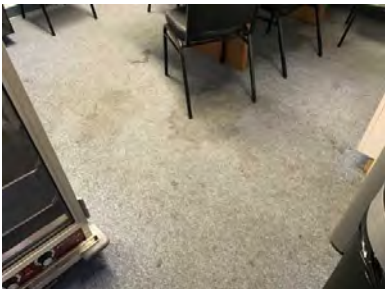
### Flooring in Poor condition.

Carpet, Commercial Standard  
E-Day Care Fairwood Explorer Elementary  
School Throughout building

The carpet is worn and has many stains throughout all spaces. - AssetCALC ID: 1998846

Uniformat Code: C2037  
Recommendation: **Replace in 2022**
