SITE FUNCTIONALITY ASSESSMENT

# **BISHOP ELEMENTARY SCHOOL**

SUNNYVALE SCHOOL DISTRICT | FACILITIES MASTER PLAN **2022**

# FACILITY CONDITION ASSESSMENT

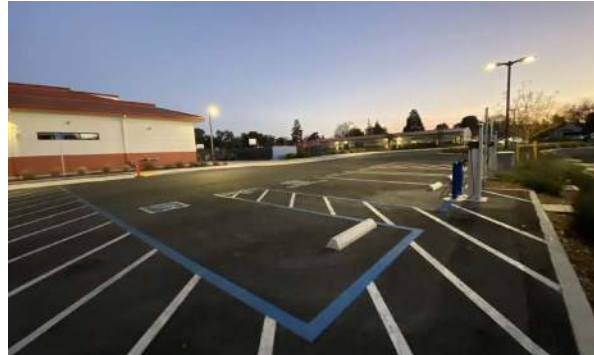
Drop-Off Lane / Parking

Parking and drop-off projects were included in the recent improvements, including EV charging stations.

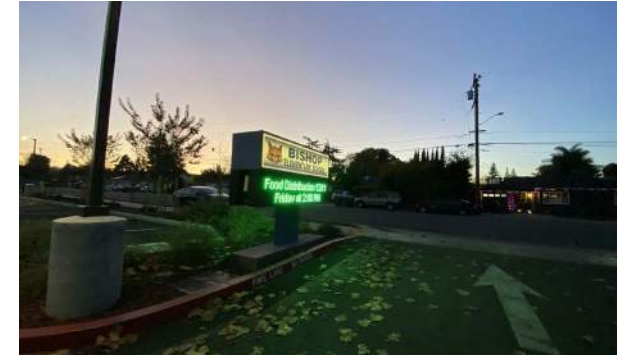
Site Identification and Announcements

The site has an electronic marquee at the frontage. Exterior site lighting is adequate.

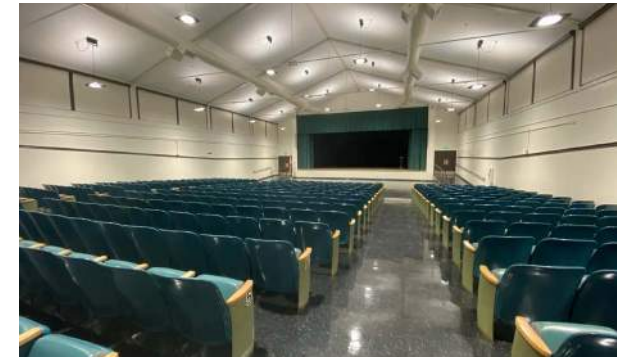
School Assembly

Assemblies are held in the Theater.

The Theater has a wall-mount, long-throw projector.

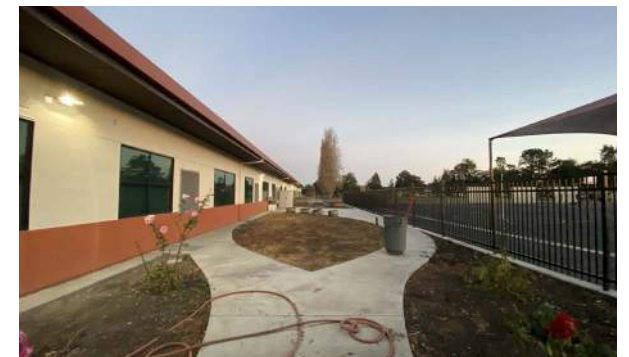
School Garden

Outdoor spaces have been improved to include seatwalls and gardens. The site has an area for full-class lectures outdoors, however teachers tend to remain within their classrooms.

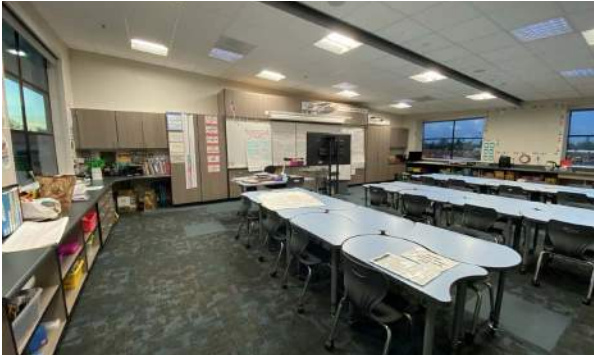
Typical Classroom

Classrooms have mobile LCD screens and wall-mount, short-throw projectors.

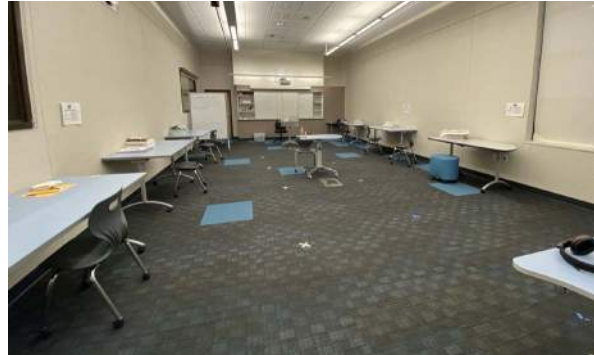
The Computer Lab (room A109) is used mainly for parent education classes in the evenings.

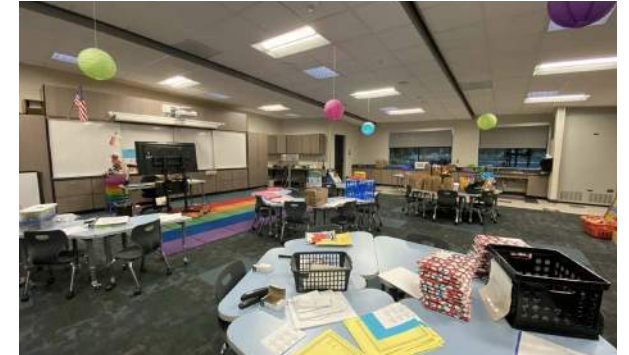
Kindergarten Classroom

All classrooms used for Kindergarten and Transitional Kindergarten (TK) are right-sized and have attached toileting facilities.

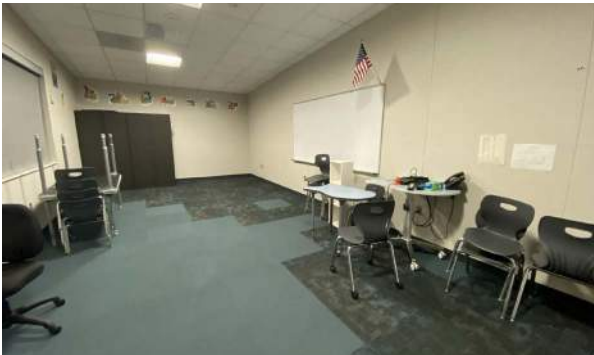
Student Services / Counseling (TLC)

Many counseling spaces such as Speech, RSP, TLC and other support providers are housed in traditional classrooms.

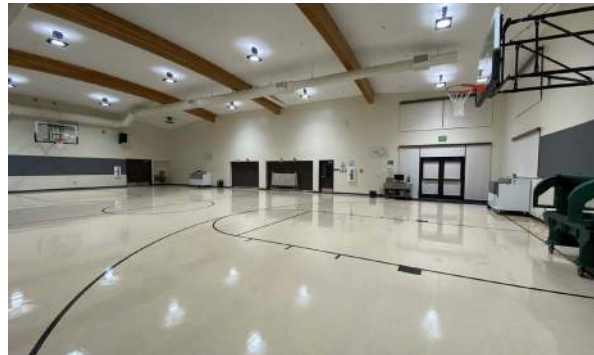
Multi-Purpose Room

However, the Multi-Use Room has basketball hoops and court striping for informal play.

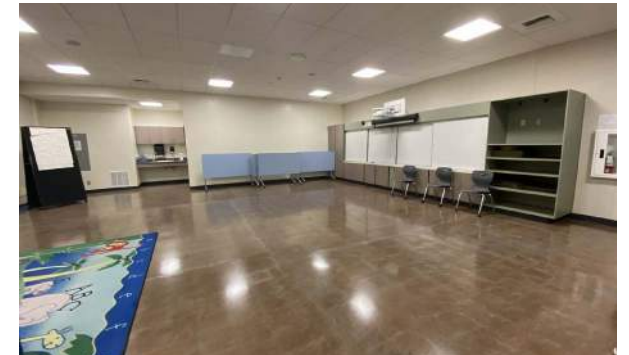
The site Program Room (also named the Enrichment Room) has polished concrete flooring with an activity rug. Furniture includes tables and chairs with casters. The tables flip up to store at the wall. This space also has a sink and attached unisex restroom.

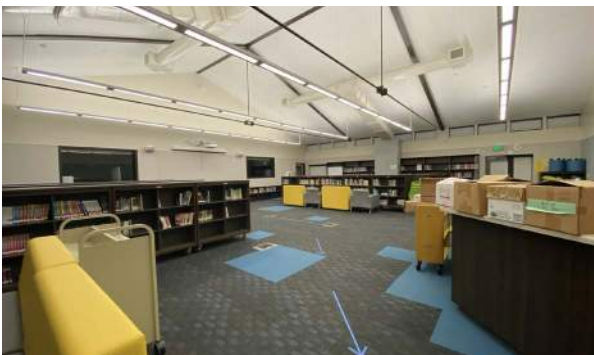
The Library has low, mobile book shelves and an assortment of mobile furniture including soft seating.

The Library has a wall-mount, short-throw projector.

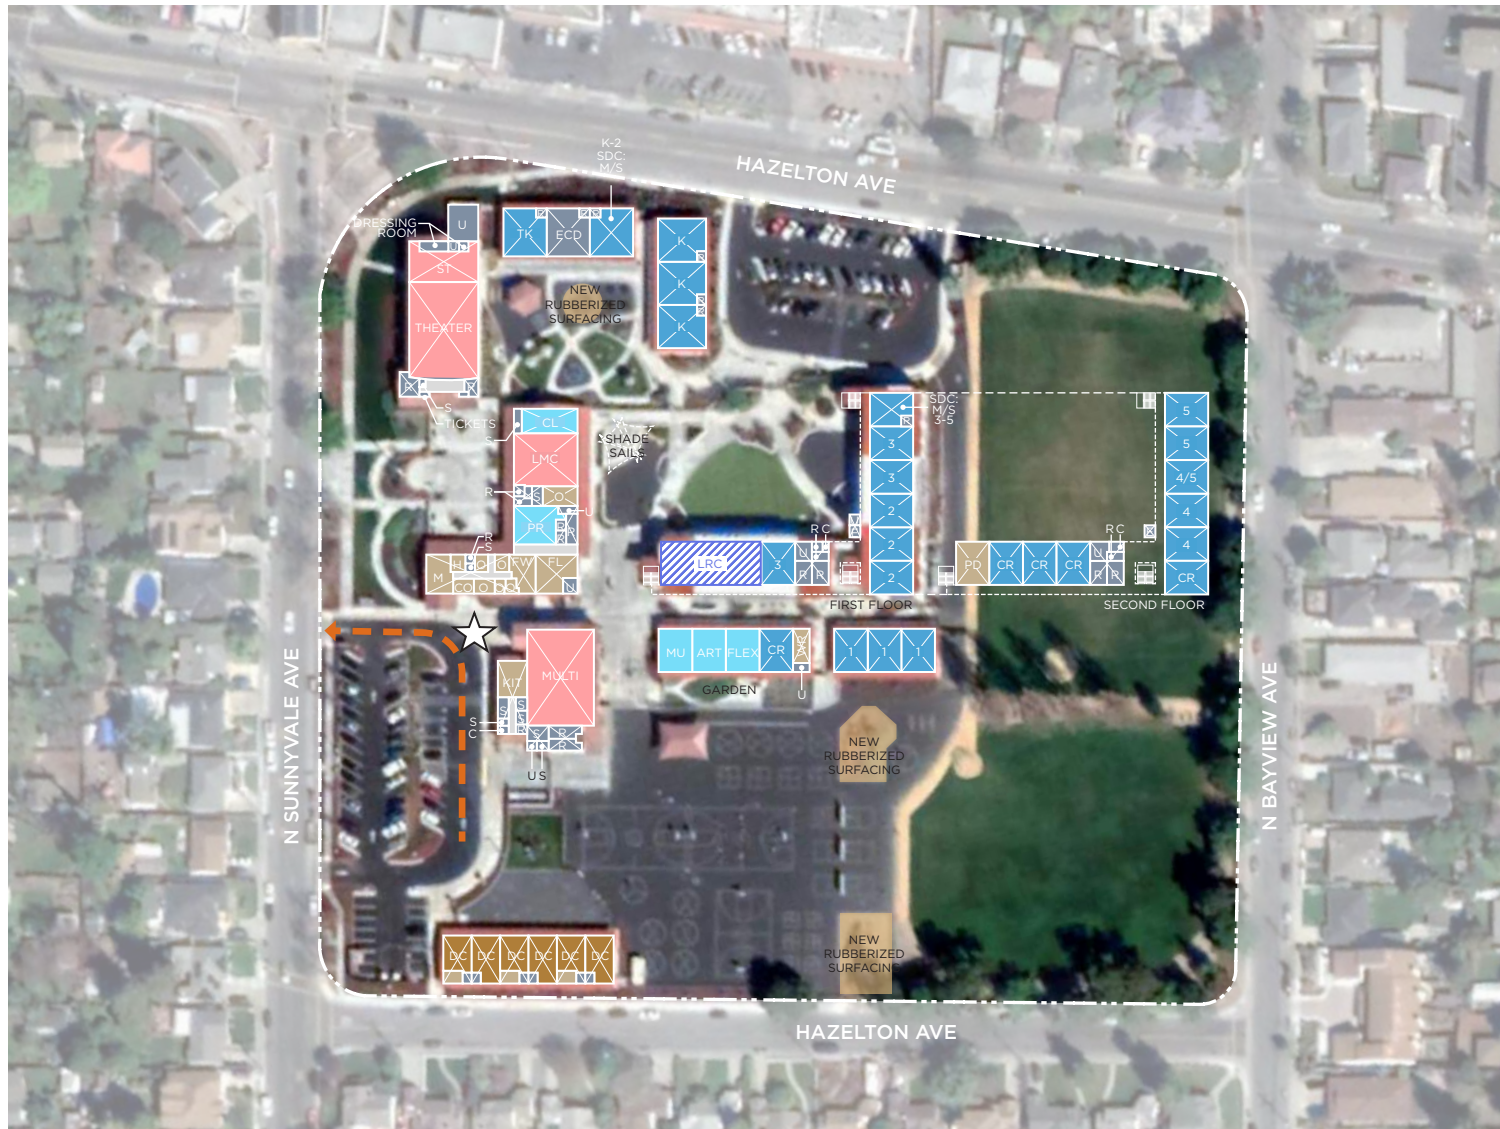
## proposed master plan diagram | BISHOP ELEMENTARY SCHOOL

- Drop-Off
- Lunch Shelter
- ★ Main Entry
- Portable Classrooms
- Entry Plaza
- Outdoor Learning/ Gardens
- New Fencing with Gates
