## El Monte Elementary School

### EXISTING SITE INFORMATION

### Property Condition

This report represents summary-level findings for the Property Condition Assessment. The deficiencies identified in this assessment can be combined with potential new construction requirements to develop an overall Long-Term Capital Needs Plan that can be the basis for a facility wide capital improvement funding strategy. Key findings from the Assessment include:

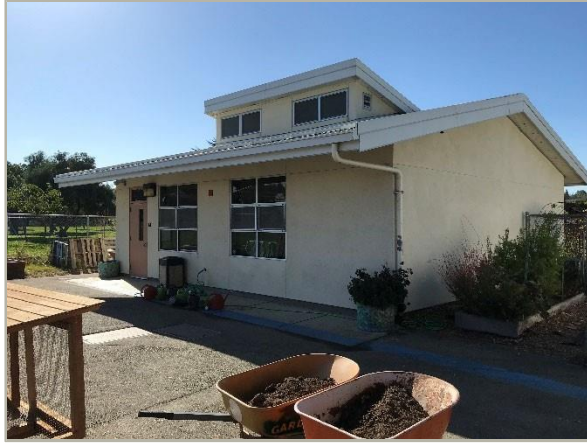
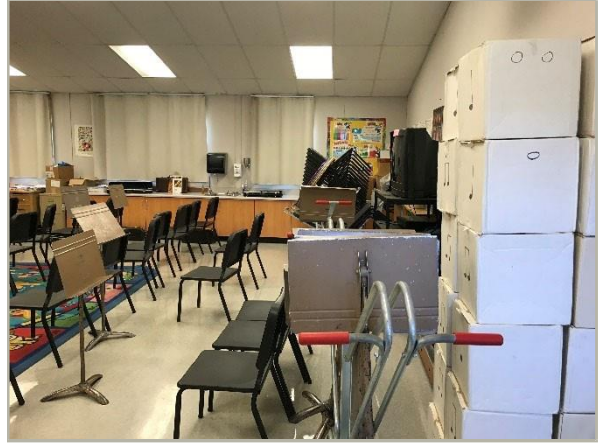
### Building Type 2 Information

| Building Type 2 Information | | |
|---|---|---|
| <b>Building Locations</b> | K3, 25, and 26 | |

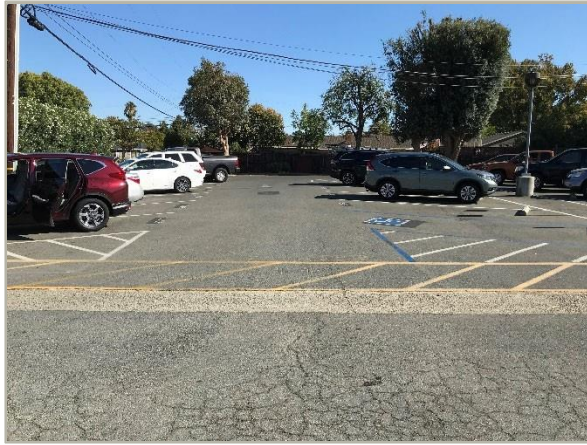
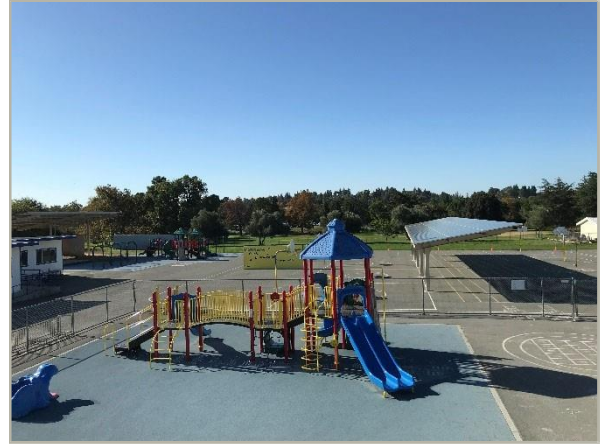
### Site Summary Information

| Site Information | | |
|---|---|---|
| <b>Lot Size</b> | 7.50 acres (estimated) | |
