## Meadow Homes Elementary School

### OVERVIEW

### Summary of Findings

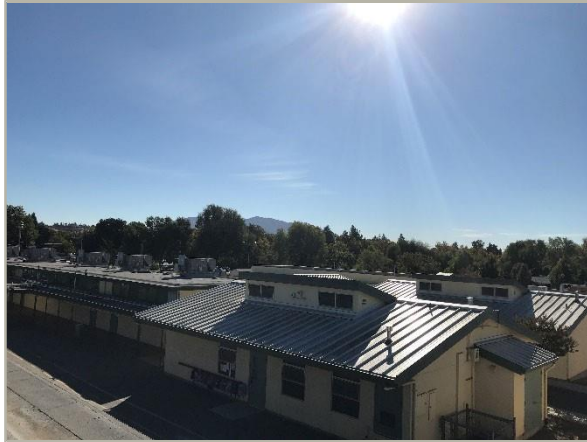
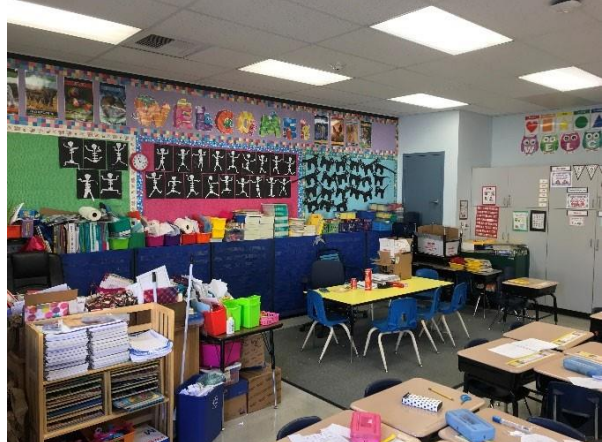
### Building Type 1 Information

| Building Type 2 Information | | |
|---|---|---|
| <b>Key Issues &amp; Findings</b> | No fire suppression or alarm in either building. ACT needs to be repaired/replaced. | |

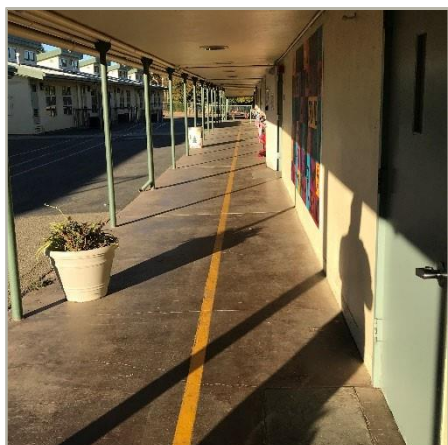
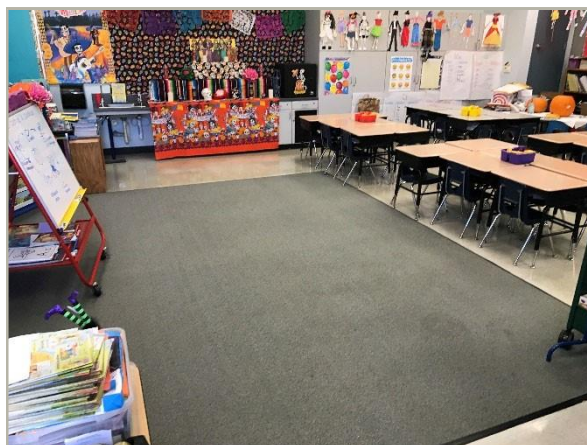
### Site Summary Information

| Site Information | | |
|---|---|---|
| <b>Draining Systems and Erosion Control</b> | Surface flow, underground piping, municipal system<br>Soil erosion not observed<br>Ponding not observed | Good |
