## Northgate High School

### Distribution of Future (Year 1-Year 10) Needs by Building System

### Building Type 1 Information

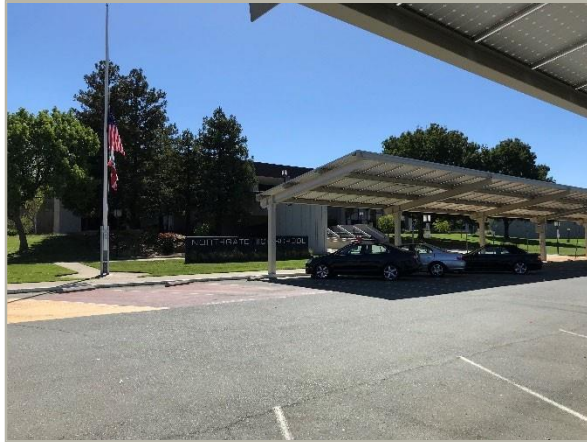
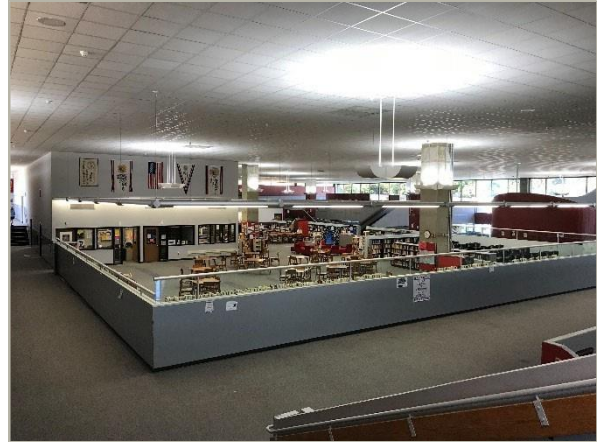
| Building Type 1 Information | | |
|---|---|---|
| <b>Building Locations</b> | Library/Administration building, Applied Art, Theater/Music, Locker/Shower and Gymnasium | |

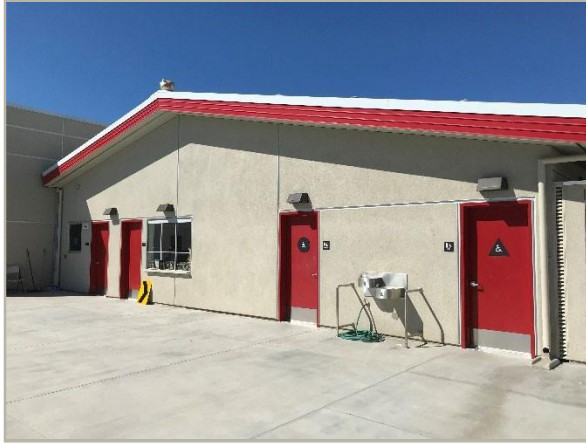
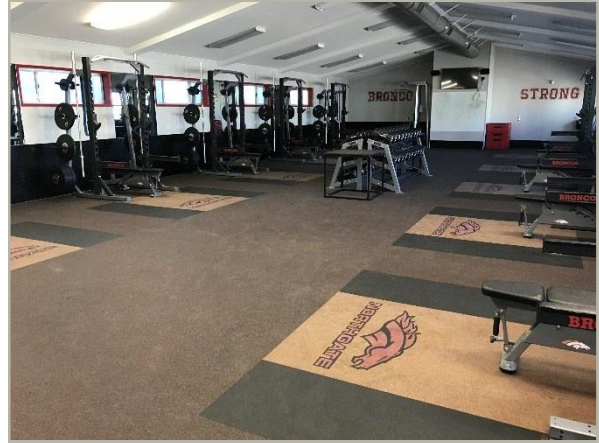
### Building Type 2 Information

| Building Type 2 Information | | |
|---|---|---|
| <b>Building Locations</b> | Building 55-57, Weight Room, Sport Med, Utility Pool room and Restroom building | |

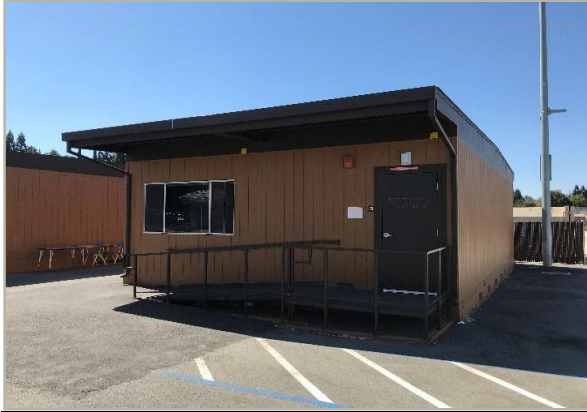
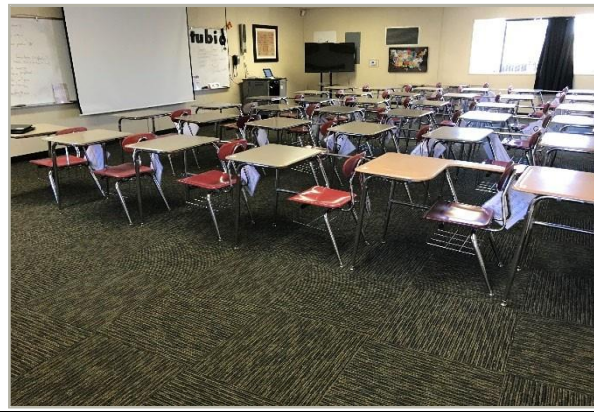
### Building Type 3 Information

| Building Type 3 Information | | |
|---|---|---|
| <b>Building Locations</b> | Portables | |

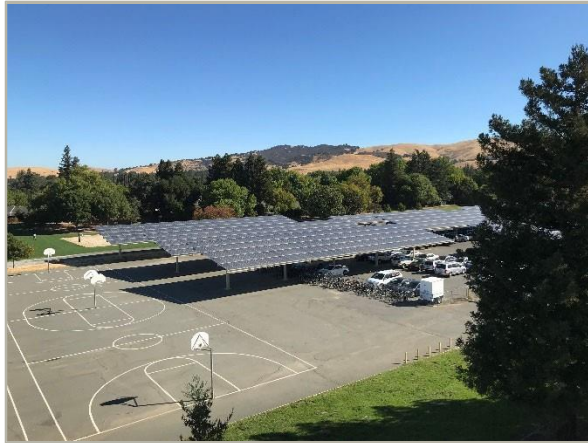
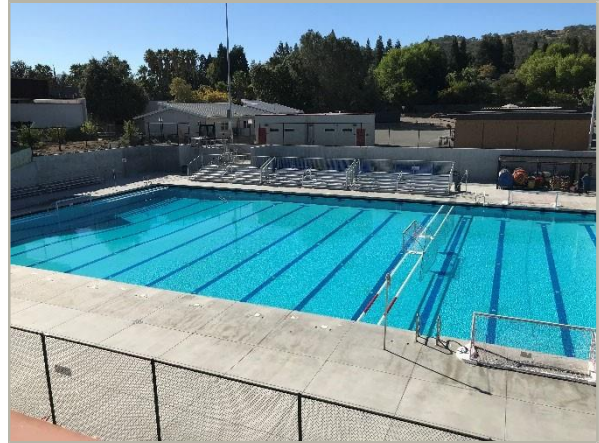
### Site Summary Information

| Site Information | | |
|---|---|---|
| <b>Lot Size</b> | 44.6 acres (estimated) | |
