## Highlands Elementary School

This report represents summary-level findings for the Property Condition Assessment. The deficiencies identified in this assessment can be combined with potential new construction requirements to develop an overall Long-Term Capital Needs Plan that can be the basis for a facility wide capital improvement funding strategy. Key findings from the Assessment include:

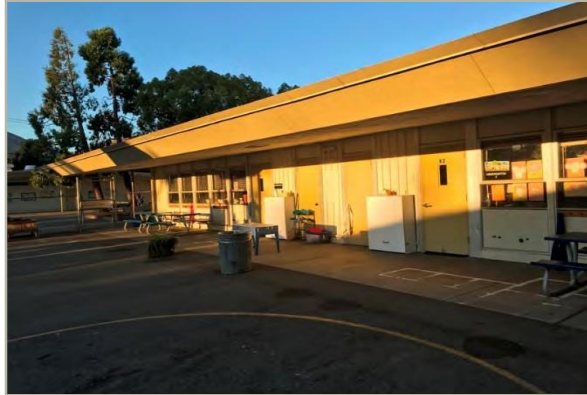
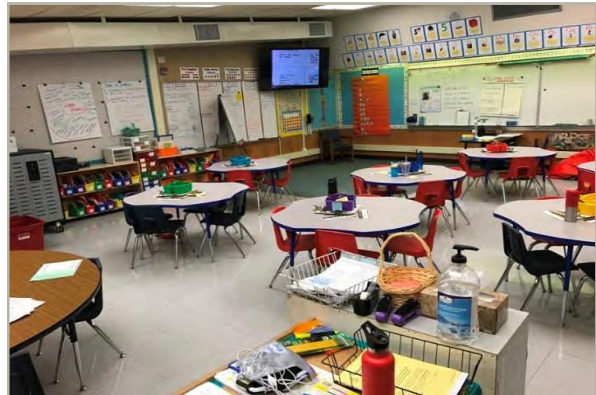
### Library/Office, Building 1-5, 6-10, 11-15, 16-24, K 1-2, 25 Information

| Library/Office, Building 1-5, 6-10, 11-15, 16-24, K 1-2, 25 Information | | |
|---|---|---|
| <b>Building Locations</b> | Classroom Buildings | |

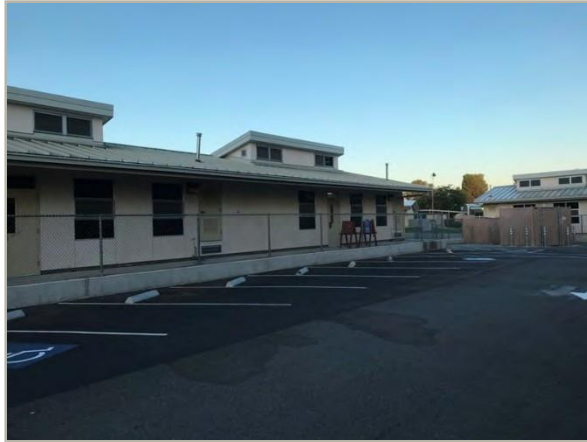
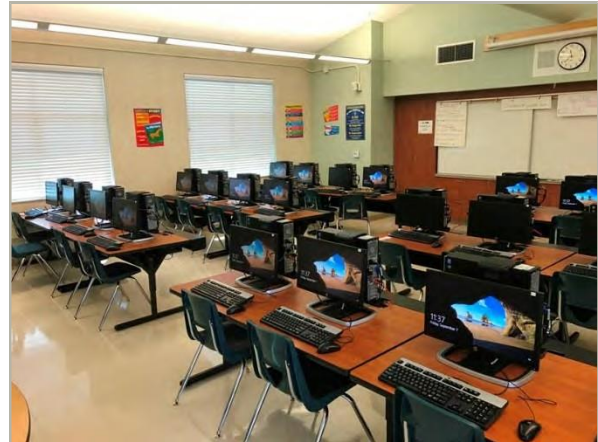
### Building K 3-4, 26-30, 31-32, 33-35 Information

| Building K 3-4, 26-30, 31-32, 33-35 Information | | |
|---|---|---|
| <b>Building Locations</b> | Classroom Building | |

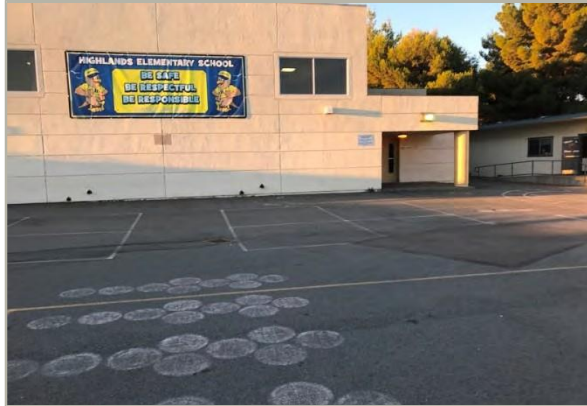
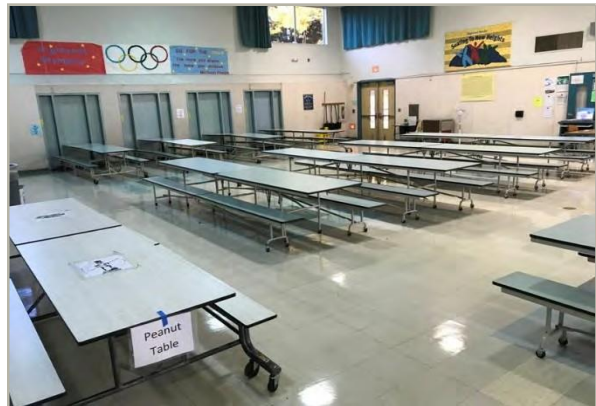
### M-U Building Information

| M-U Building Information | | |
|---|---|---|
| <b>Building Locations</b> | Multipurpose, Kitchen | |

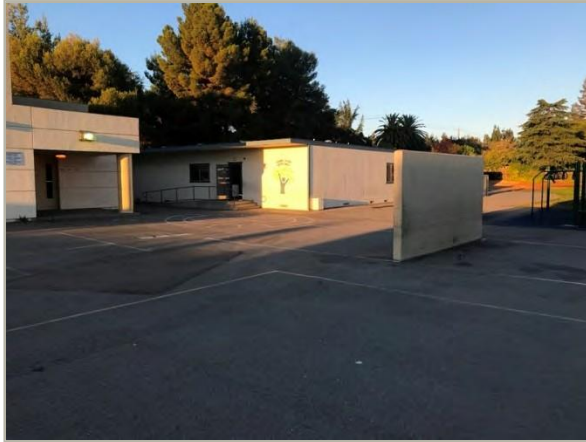
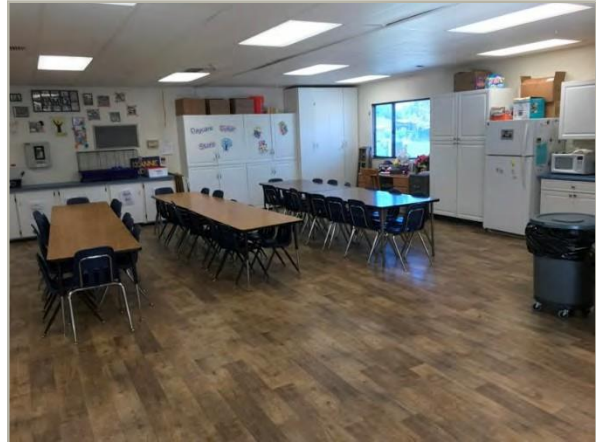
### Daycare Building Information

| Daycare Building Information | | |
|---|---|---|
| <b>Building Locations</b> | Daycare | |

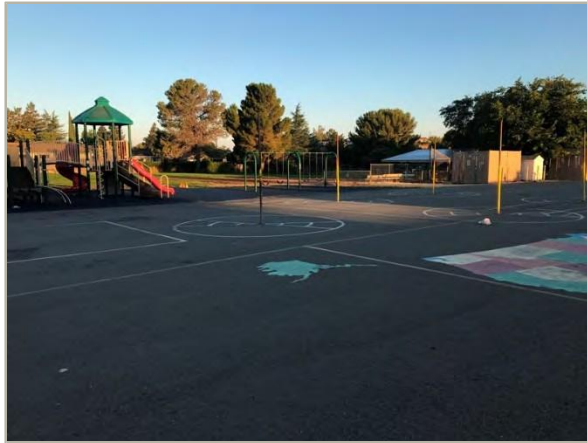
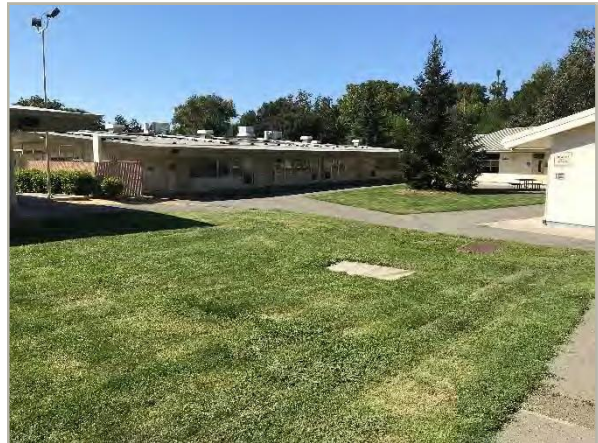
### Site Summary Information

| Site Information | | |
|---|---|---|
| <b>Lot Size</b> | 6.50 acres (estimated) | |
